# Flooded With Problems

## Stormwater Management on the SMC Coast Situation, Causes, Solutions and Recommendations

Agency Review Draft - Jan. 8, 2025

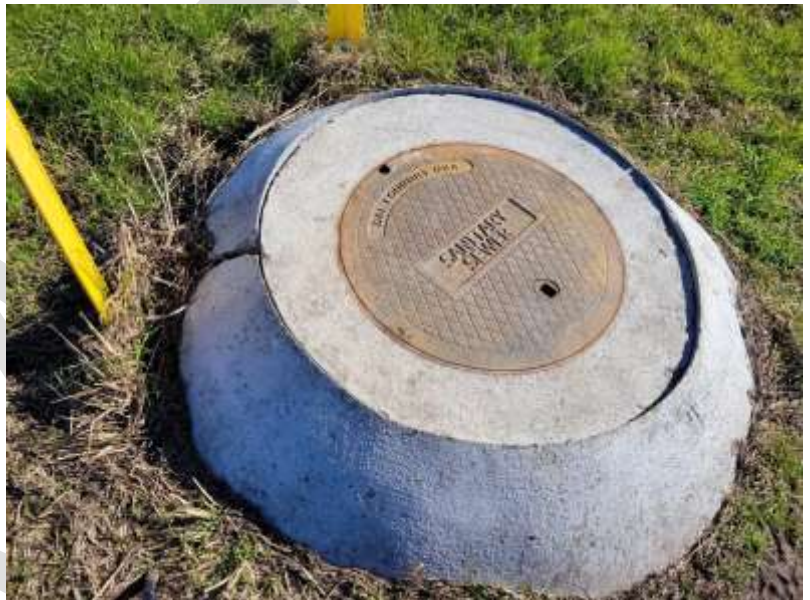
HMB seems to be aware of the I&I issues, at least in part. For example, on Wavecrest a few years back the City “domed” a number of the manholes on the sewer pipes extending from Ocean Colony and the Ritz, to elevate them above the standing water on those lands, which persists for weeks during the rainy season (photo below). Note that some of them have developed cracks.

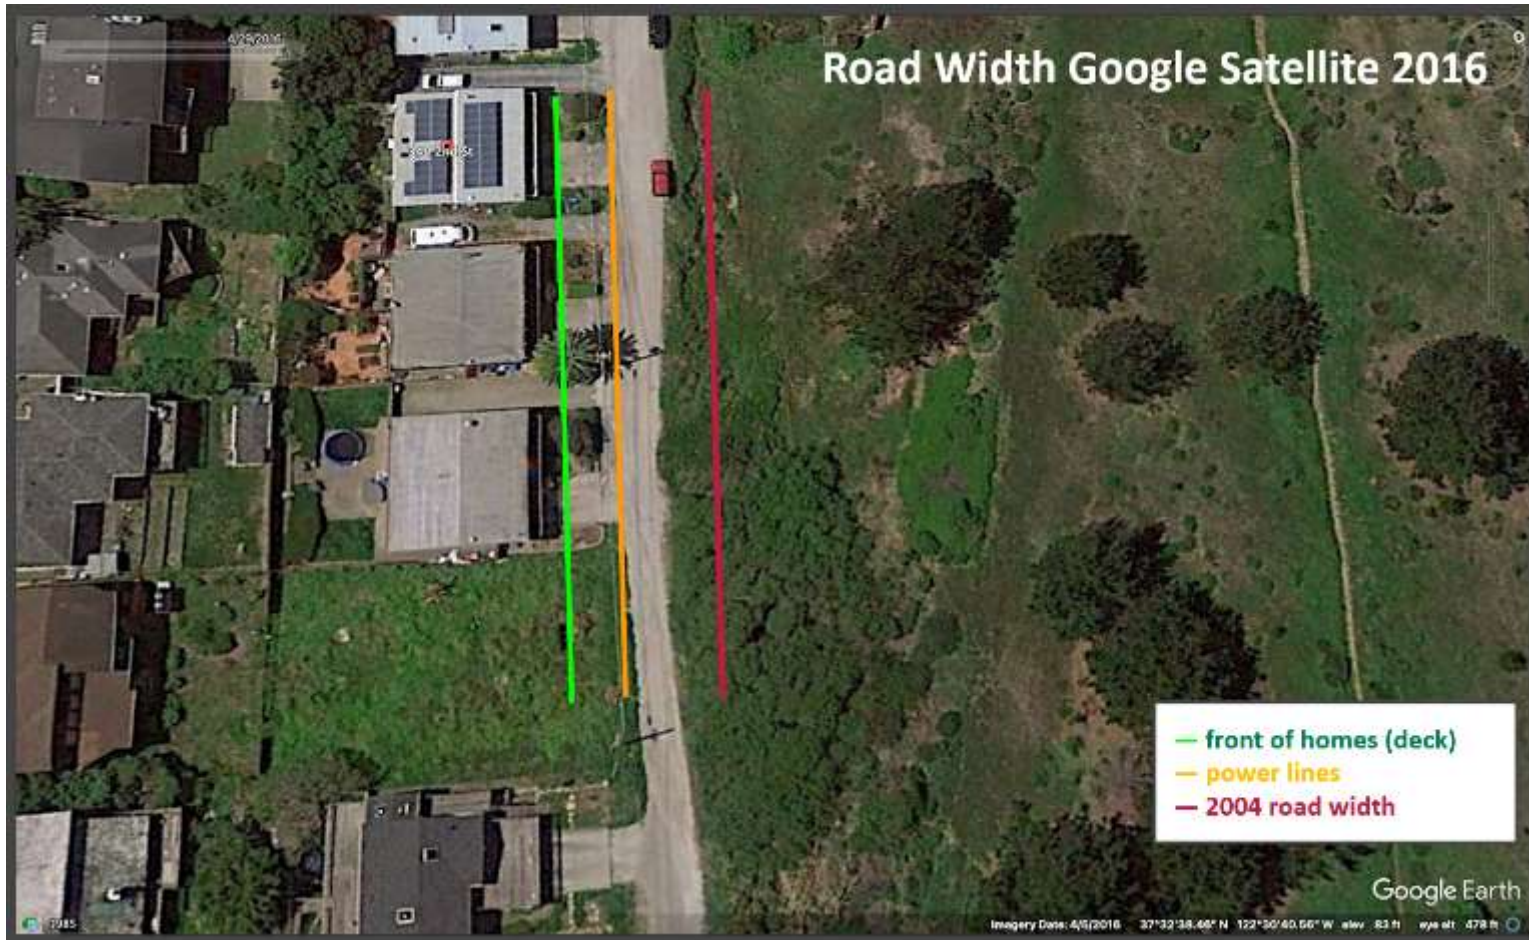
These pictures show the loss of roadway due to repeated stormwater damage:

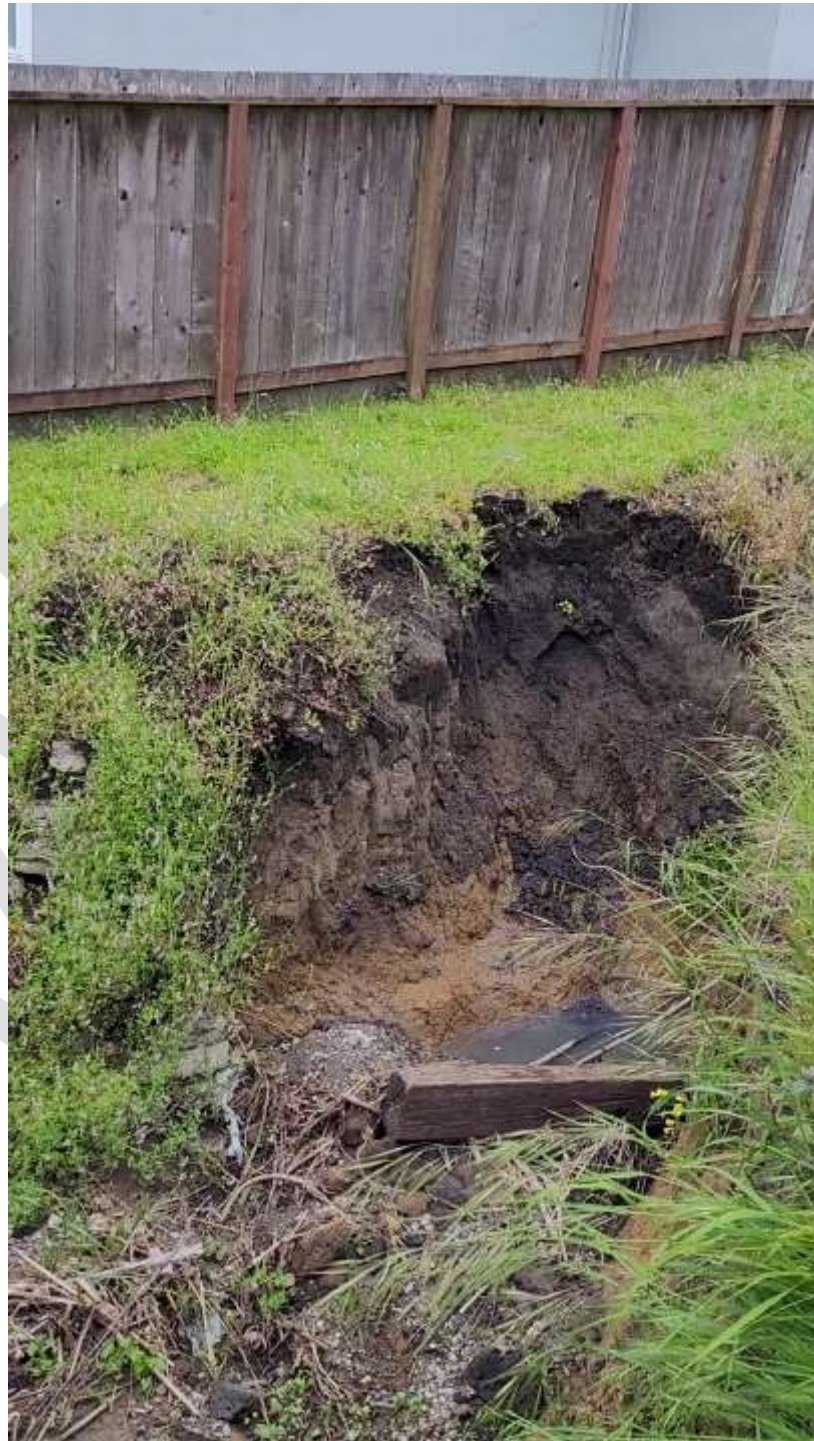
Figure 3 Gully on "East" between 4th and 3rd Sts.

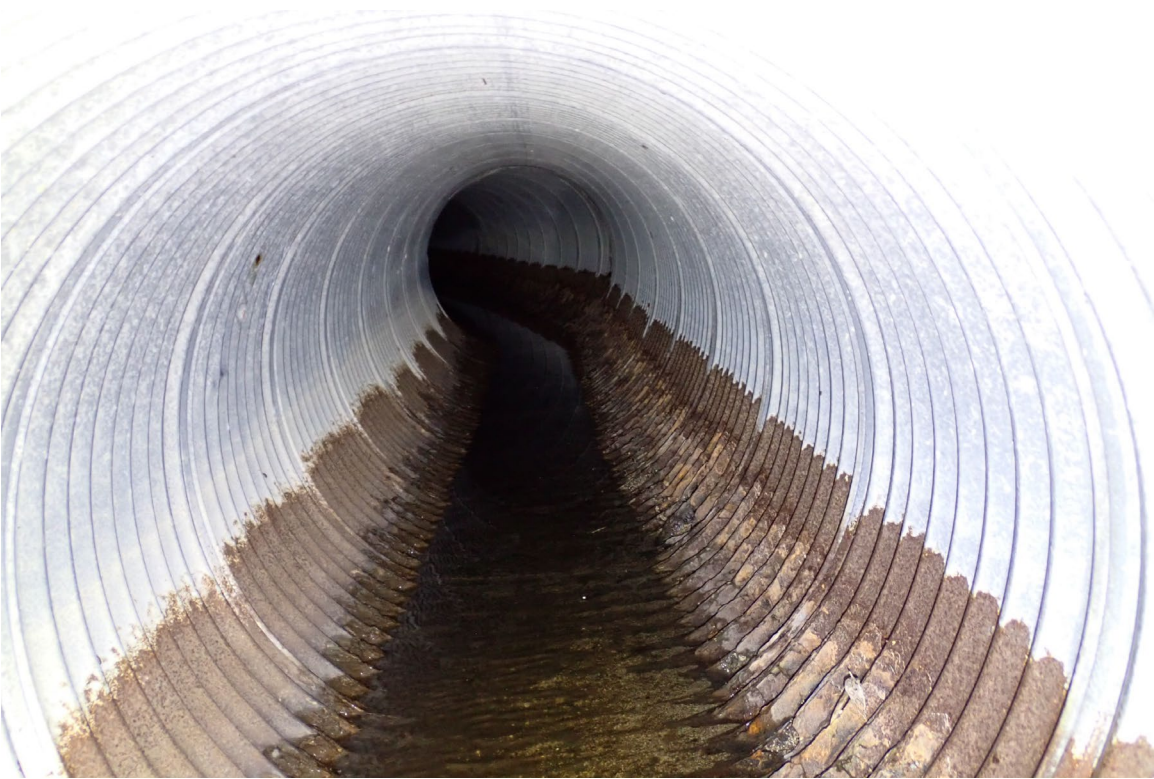
**Figure 14** Interior of 29" culvert under 2805 Naples Ave, viewed from outlet

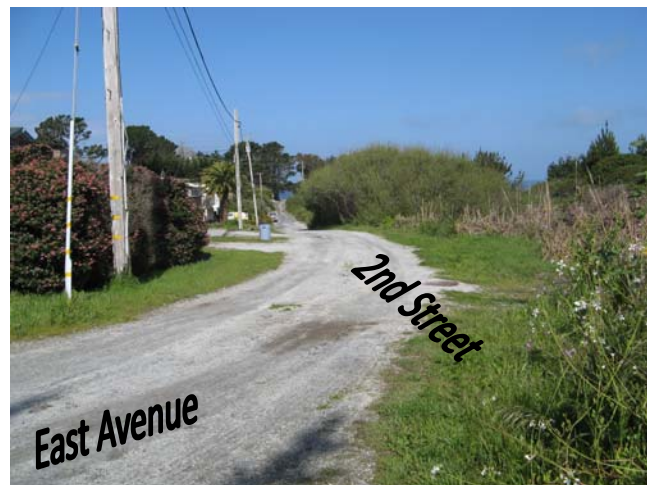
**Photo 1** Photo taken from corner of 2<sup>nd</sup> Street and East Avenue, looking west down 2<sup>nd</sup> Street. A good-sized gully exists at photo left, between the telephone pole and pink flowering escallonia (see also Photo 3). The riparian area is in the photo on the right, on the other side of 2<sup>nd</sup> Street and the dried Pampas grass. Note the large willow thicket in the middle of the photo.

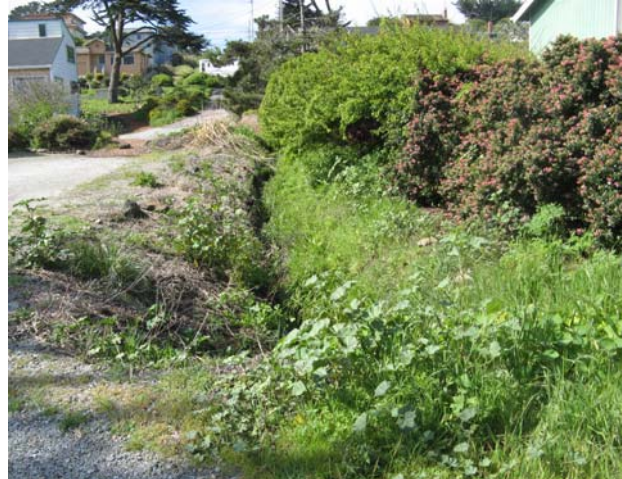
Photo 2. Looking east from the corner of 2<sup>nd</sup> Street and East Avenue. Note that the riparian area is on the other side of the street (outside of photo left), and also note the gully in middle of photo.

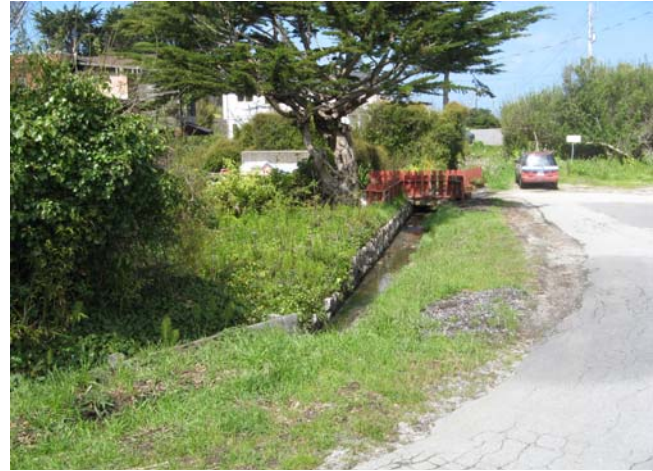
**Photo 5.** Looking at the southwest corner where Kanoff Street changes from north/south to east/west. Note the large willow thicket in the photo background that identifies this as a wetland.

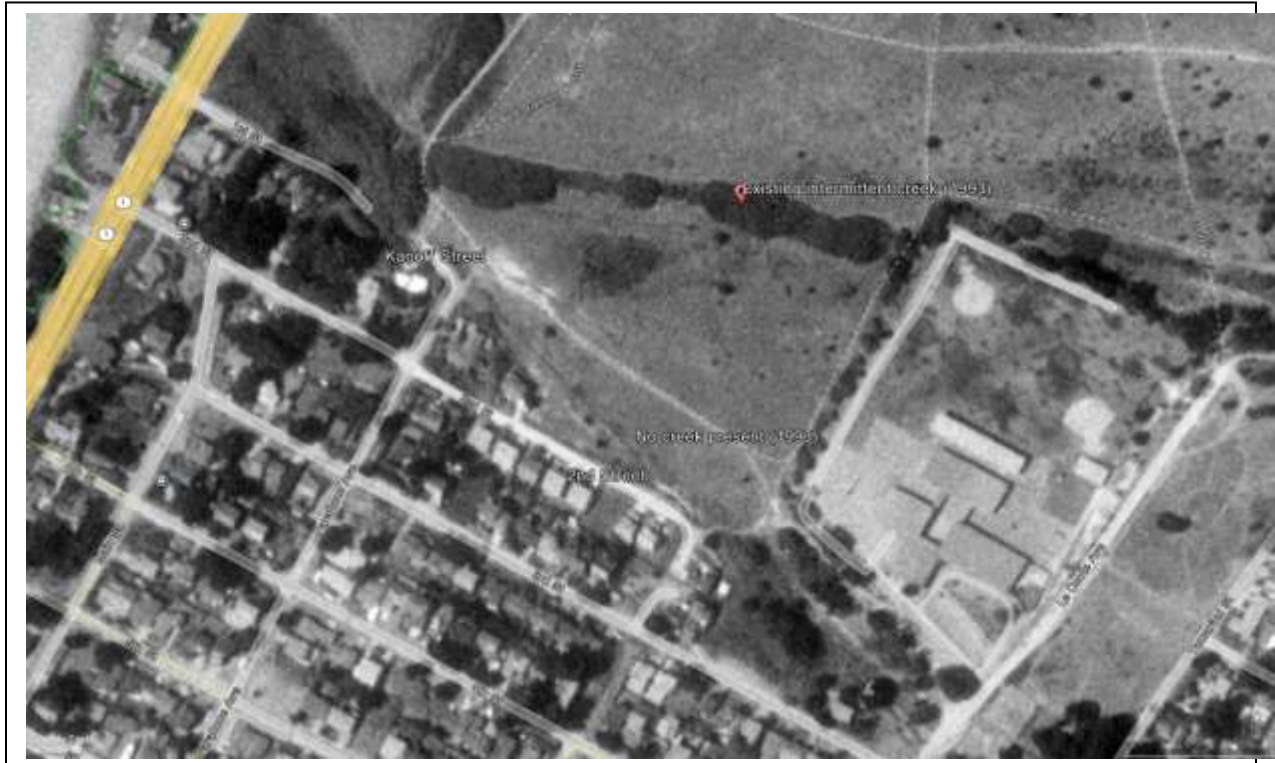
Figure 1. Aerial from 1993 showing that there was no creek or riparian corridor present along 2nd Street and Kanoff Street. Creek started forming in the 1990's. Source: Google Earth.

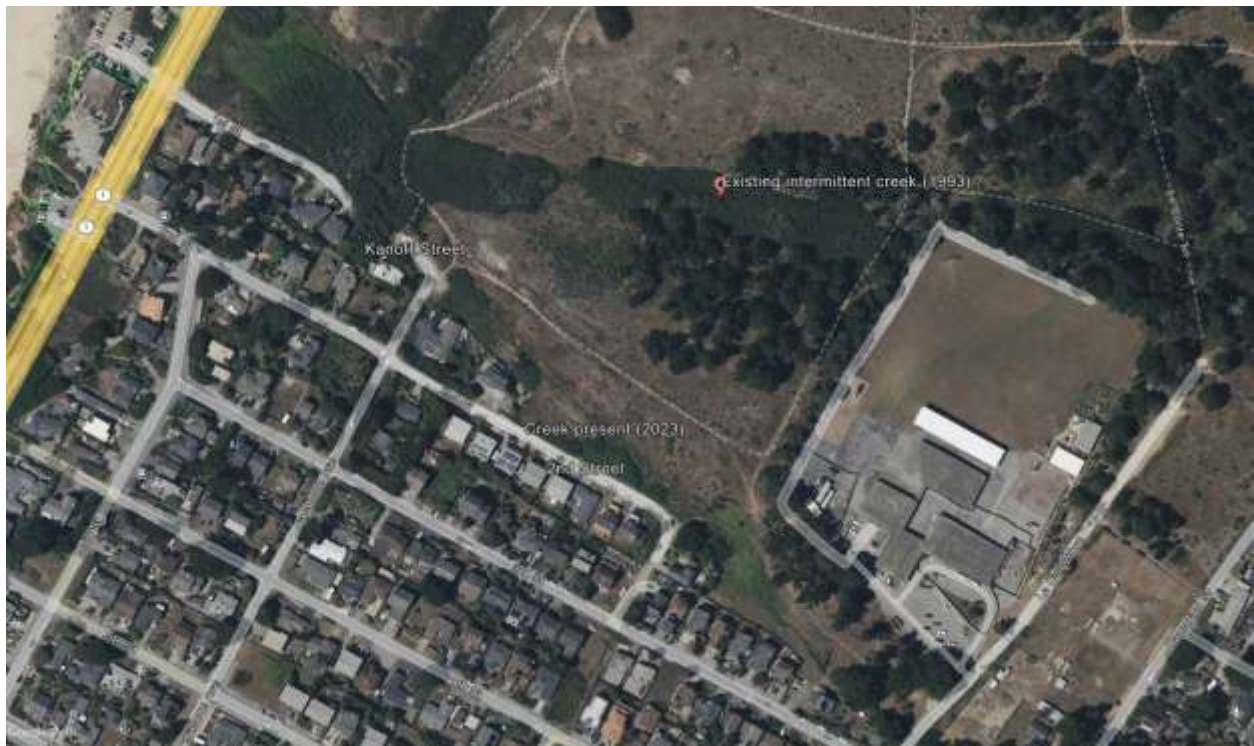
Figure 2. Aerial from 2023 showing establishment of creek and riparian corridor along 2nd Street and Kanoff Street. Source: Google Earth.

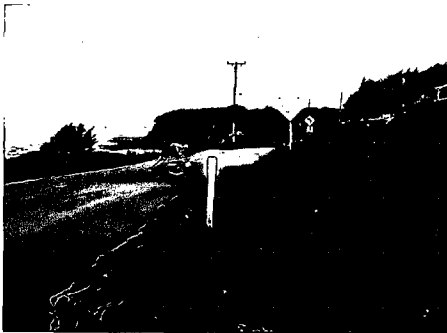
The southern end of the recent activity appears to be near the intersection of Ocean Blvd and San Lucas Avenue. This view is from that intersection, looking northward.
