SUBJECT: Final Engineering Geologic Report of the Seal Cove -
Moss Beach Area, County of San Mateo

GEOLOGIC REPORT
OF
SEAL COVE - MOSS BEACH AREA

Prepared for
THE COUNTY OF SAN MATEO
in Accordance with Resolution 29451

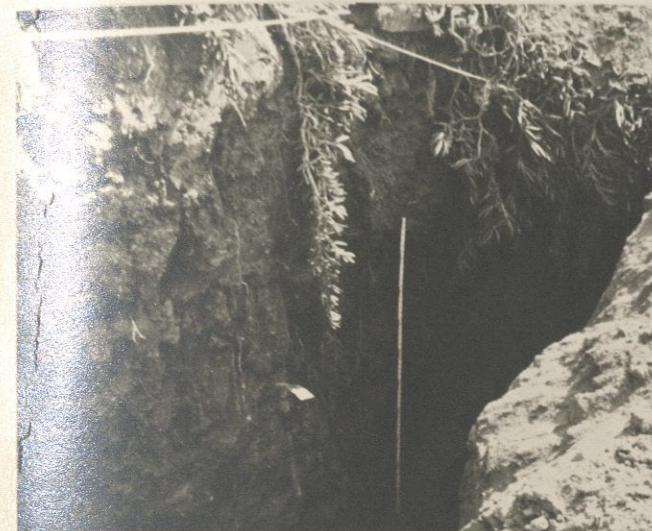
PIT 5

9-24-71 B.D. Photo 1
Looking south at active scarp
(between mattock & ruler, behind
ice plant)

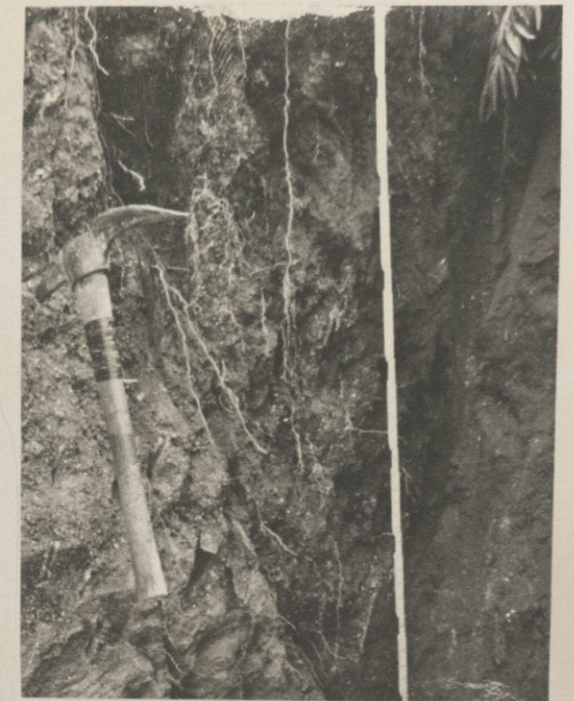
PIT 5

9-24-71 B.D. Photo 2
Close-up of view in Photo 1.
Active scarp is down on right and
filled with soil debris. Qt to
left of scarp line.

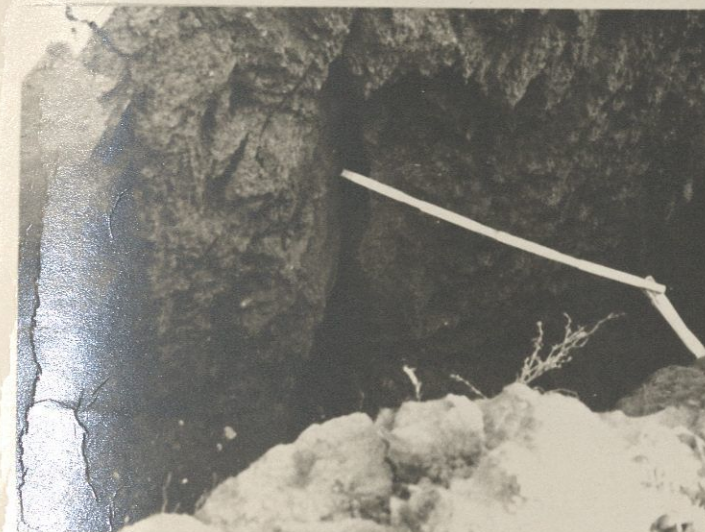
PIT 8

9-24-71 B.D. Photo 3
Open crack (1-1/2") along scarp
line on Los Banos St. Qt on left,
soil on right.

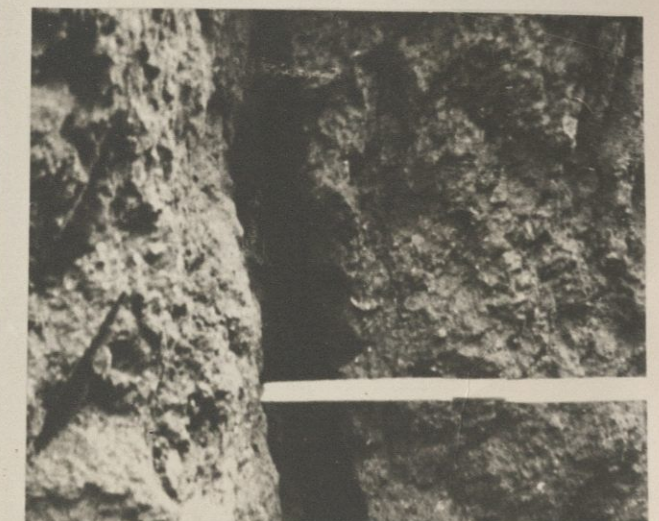
PIT 8

9-24-71 L.C. Photo 4
Close-up of Photo 3 showing
1-1/2" open crack which forms
scarp at ground surface.
