Seal Cove-Moss Beach Area
San Mateo County
10-15-71
LEIGHTON

October 15, 1971

INTRODUCTION
OF
TECHNICAL PORTION

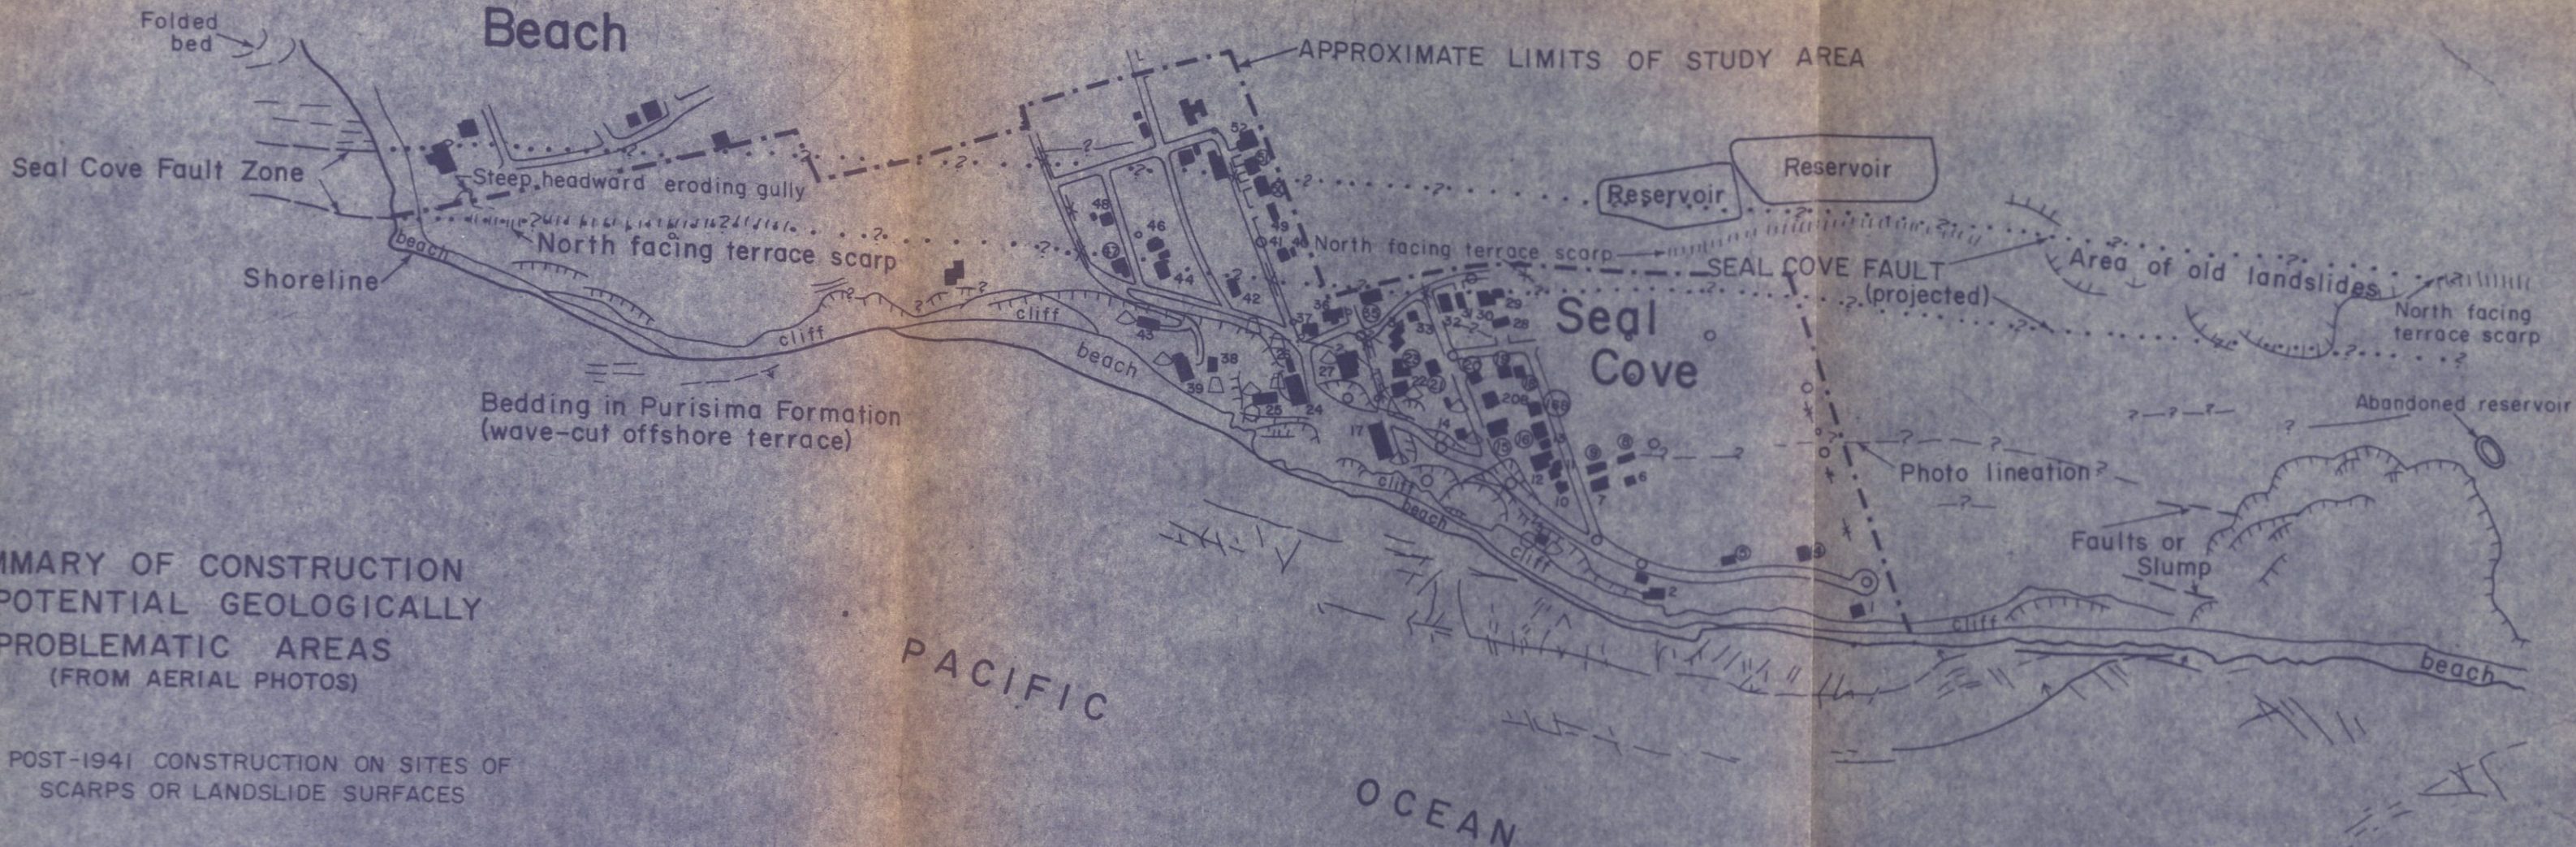
PHOTOLOGIC INDEX MAP of SEAL COVE-MOSS BEACH AREA SAN MATEO COUNTY

SUMMARY OF CONSTRUCTION IN POTENTIAL GEOLOGICALLY PROBLEMATIC AREAS (FROM AERIAL PHOTOS)

- △ POST-1941 CONSTRUCTION ON SITES OF SCARPS OR LANDSLIDE SURFACES
- POST-1965 CONSTRUCTION ON FRESH SCARPS VISIBLE ON 1965 PHOTOS
- △ LOCATION OF DWELLINGS ON THE 1941 PHOTOS THAT HAVE SINCE BEEN REMOVED
