# Flooded With Problems

## Stormwater Management on the SMC Coast Situation, Causes, Solutions and Recommendations

Agency Review Draft - Jan. 8, 2025

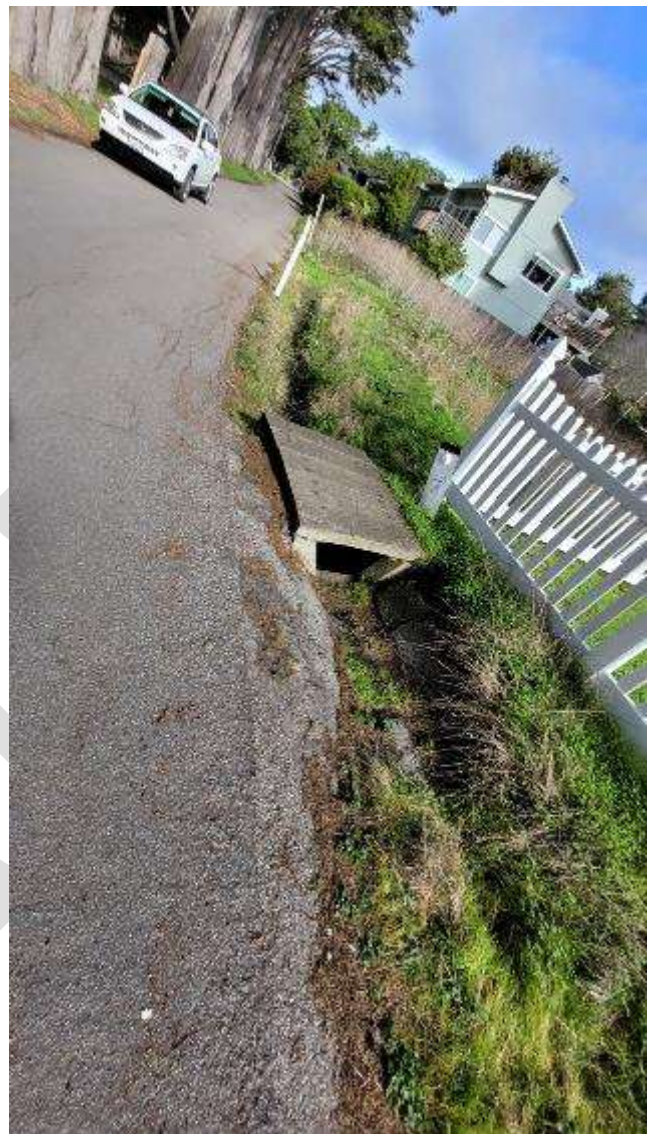
*Figure 5 Overlarge Catch Basin Opening on Cypress*

4. Place rods on the Cypress Ave. catch basin to prevent small children from accidentally falling into the culvert.

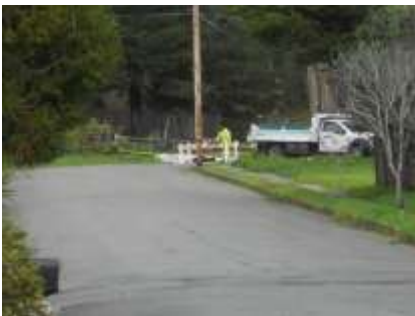
The two flows exit the Park at the intersection of Santa Maria Ave. & Columbus St near the Park's entrance (see Photos 03, 07, & 18 in Exhibit 2). The larger and more impactful flow floods down Santa Maria whereas the lesser flow, until recently, also primarily flooded down Santa Maria with a much lesser impact to Columbus. Recently though, because of the quantity of flooding stormwater, such as after the January 2023 storm (see Photos 18 to 25), the SMC Parks Department diverted the lesser flow down Columbus (see Photos 01 to 05). This helped reduce the flooding down Santa Maria and its impact to homes on that street and, for which, the residents were greatly thankful<sup>12</sup>. Nonetheless, this newly increased diverted flow adversely effected the health & safety of residents on Columbus with Park flows flooding down 3 blocks (approx. 1,200 linear ft.) to a pseudo storm drain at Santiago Ave. then under that road to openly run into a meadow on the road's western side (see Photos 05 & 06).

Photo 01 - Diverting lesser stormwater flow from Quarry Park at Park entrance (intersection of Santa Maria & Columbus)

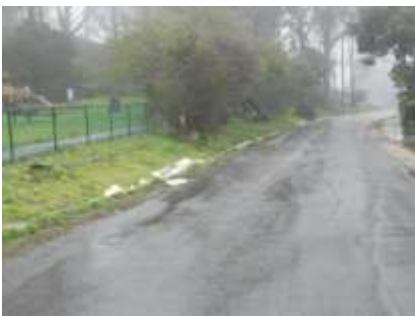
Photo 03 - Diverted lesser Park stormwater flow at Park entrance flooding down Columbus

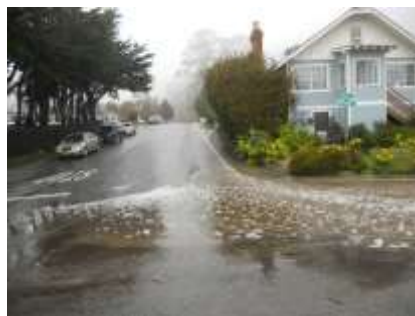
Photo 04 - Diverted lesser Park stormwater flow flooding down Columbus (towards Santiago)

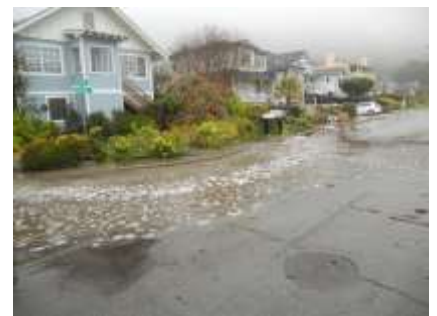
Photo 05 - Diverted lesser Park stormwater flow flooding down Columbus to Santiago

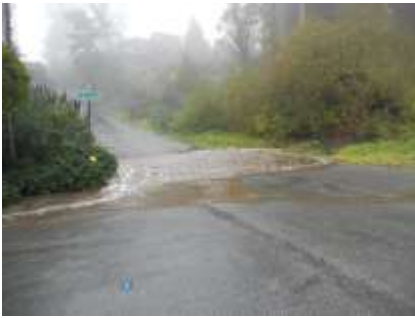
Photo 06 - Diverted lesser Park stormwater flow flooding into pseudo storm drain at intersection of Columbus & Santiago then under street to meadow below

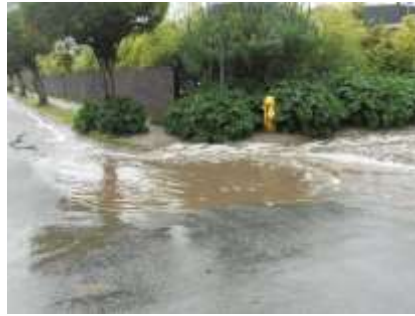
The Park's larger stormwater flow onto and down Santa Maria starts at the Park's entrance then floods over cross streets beginning with Columbus, then to Francisco, then to Palma into a pseudo storm drain at the end of Santa Maria at intersection with The Alameda (see Photos 07 to 12). The stormwater runoff then floods under the east side of The Alameda to an open-air ditch in its median to a new catch basin at Ave. Cabrillo (see Photos 13 & 14). At the Ave. Cabrillo catch basin, stormwater enters an underground storm system flowing down Ave. Cabrillo to a storm drain as part of the underground storm system at Ave. Alhambra (see Photos 15 to 17). This process catches all of the runoff down Santa Maria even when the lesser flow from the Park is not diverted by the Parks Dept. - but the flooding is much more intense getting to the drain in that case.

Photo 07 - Larger Park stormwater flow flooding down Santa Maria near Park entrance at intersection of Santa Maria & Columbus

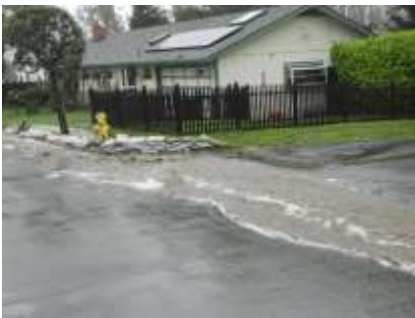
Photo 09 - Larger Park stormwater flow flooding down Santa Maria at x-street Francisco

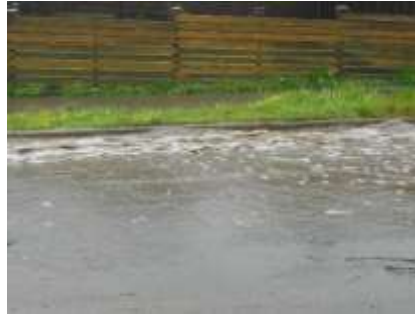
Photo 10 - Larger Park stormwater flow flooding down Santa Maria at x-street Palma

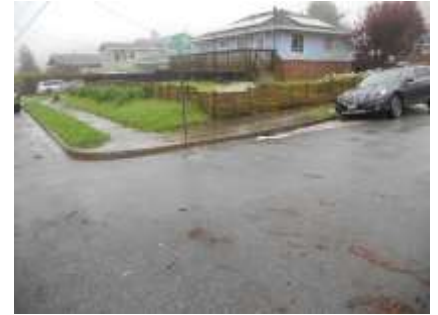
Photo 11 - Larger Park stormwater flow flooding down Santa Maria just above pseudo storm drain

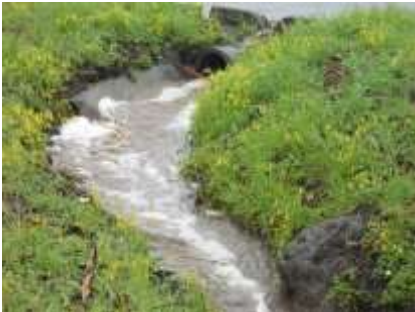
Photo 12 - Larger Park stormwater flow flooding into pseudo storm drain at end of Santa Maria at intersection with The Alameda

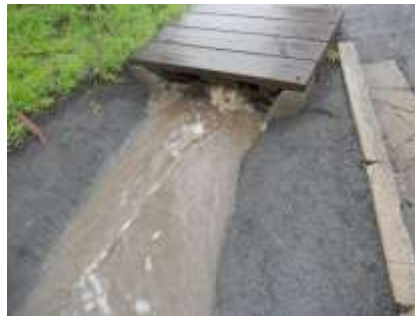
Photo 13 - Larger Park stormwater flow flooding from pseudo storm drain under the eastern side of The Alameda to open-air ditch in its median

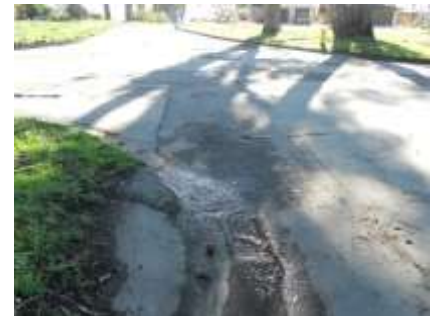
Photo 14 - Larger Park stormwater flow flooding from ditch into catch basin as entry into an underground storm system at The Alameda & Ave. Cabrillo

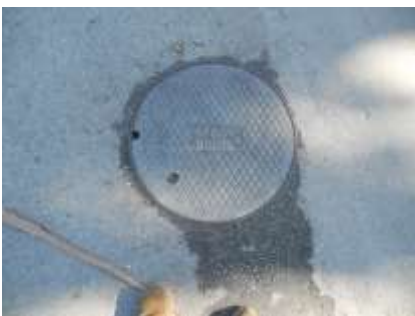
Photo 15 - Underground storm system from catch basin entry to manhole cover in Ave. Cabrillo at intersection with The Alameda

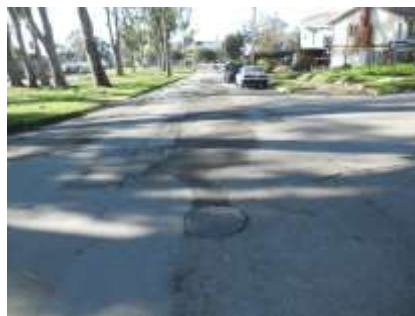
Photo 16 - Underground storm system manhole cover in Ave. Cabrillo at intersection with The Alameda

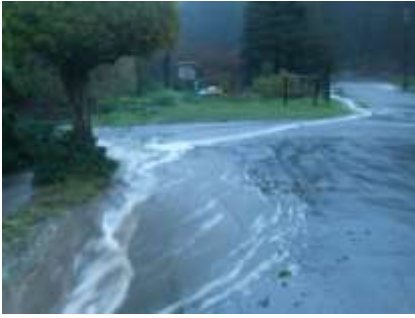
Photo 18 - Two stormwater drainage & runoff flows over intersection of Santa Maria & Columbus at Park entrance

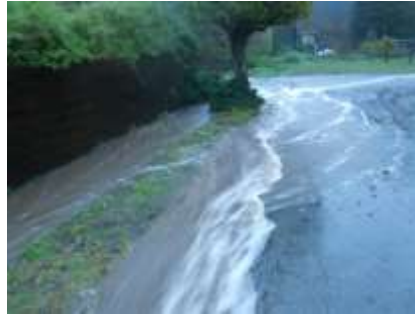
Photo 19 - Two stormwater drainage & runoff flows down Santa Maria

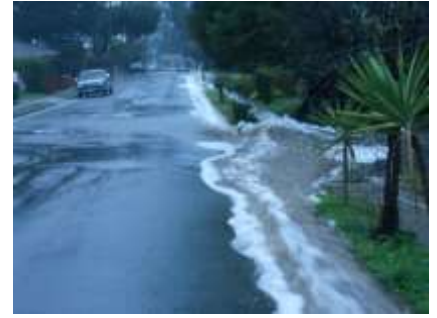
Photo 20 - Two stormwater drainage & runoff flows down Santa Maria over x-street Francisco

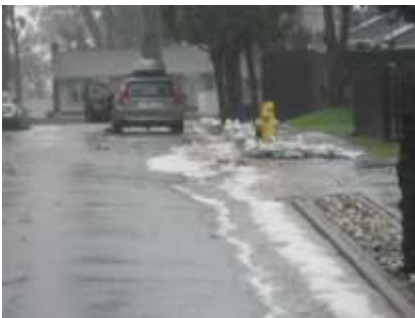
Photo 21 - Two stormwater drainage & runoff flows down Santa Maria over x-street Palma

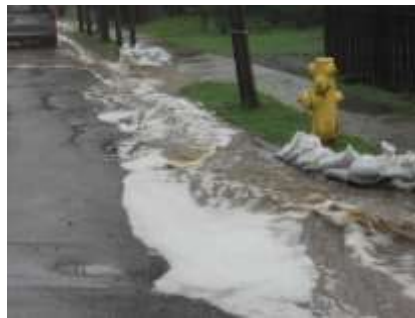
Photo 22 - Two stormwater drainage & runoff flows down Santa Maria at Palma

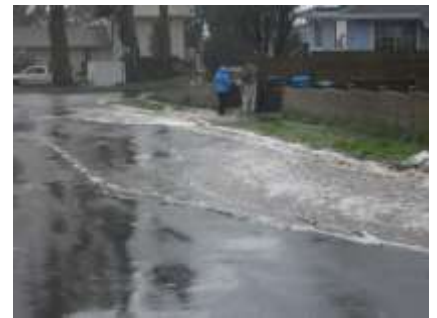
Photo 23 - Two stormwater drainage & runoff flows at Santa Maria end towards The Alameda into the pseudo storm drain

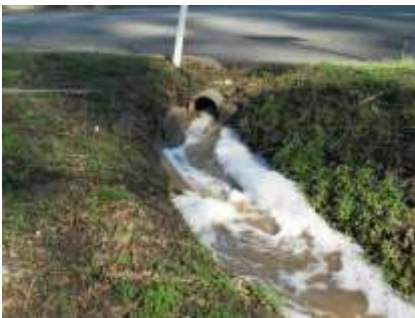
Photo 24 - Two stormwater drainage & runoff flows from pseudo storm drain under the eastern side of The Alameda to open-air ditch in its median

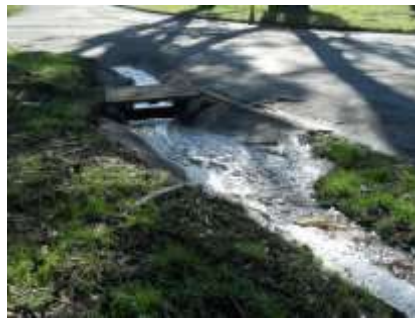
Photo 25 - Two stormwater drainage & runoff flows into underground storm system catch basin at The Alameda & Ave. Cabrillo from the open-air ditch

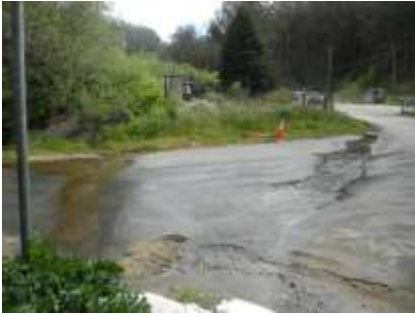
Update – On April 15, 2023, even after a month of no rain, both flows exiting Quarry Park showed steady and significant runoff. However, both were now running down Santa Maria since the lesser flow was no longer being diverted down Columbus. (See Photos 70 to 73)

Photo 70 - Two stormwater drainage & runoff flows from Quarry Park entrance at Santa Maria & Columbus

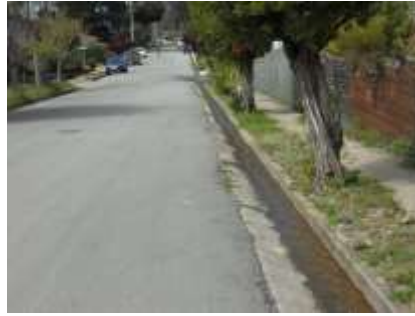
Photo 71 - Two Park stormwater drainage & runoff flows down Santa Maria from Columbus to The Alameda

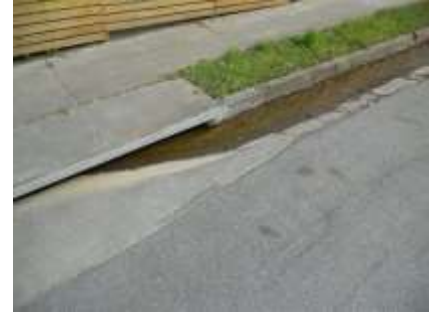
Photo 72 - Two Park stormwater drainage & runoff flows into pseudo storm drain at Santa Maria & The Alameda - then under The Alameda to an open-air ditch in its median

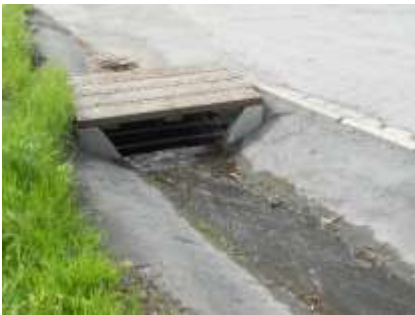
Photo 73 - Two Park stormwater drainage & runoff flows from the open-air ditch into a catch basin as entry into an underground storm system at The Alameda & Ave. Cabrillo

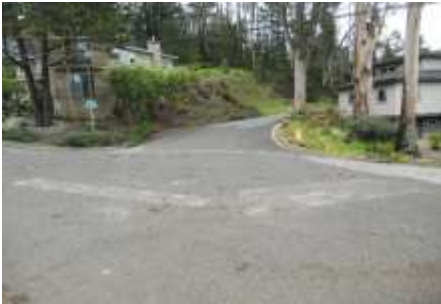
Following the path of stormwater runoff that flooded down Ave. Portola, after the March, 2023 storm, to its source showed it originated at the intersection of Ave. Portola & Columbus St. It flowed from a large pipe under and culvert at Columbus that bellowed stormwater from the Highlands above (see Photos 26 & 27). The stormwater then flowed down Ave. Portola in deep open-air ditches occasionally passing through pipes under residential driveways and flooding over Francisco and Palma Streets to The Alameda (see Photos 28 to 32). It then divided into two directions. One flooded down The Alameda towards Isabella Ave. to a pipe under the eastern side of The Alameda to a culvert in its median (see Photos 33 to 36). The second down Ave. Portola and over Coronado St to a storm grate and drain that are part of an underground storm system at Ave. Alhambra (see Photos 37 to 39). For approx. 1,800 linear feet down Ave. Portola and approx. 300 linear feet down The Alameda, stormwater floods down the residential streets and into neighborhoods without abatement.

Photo 26 - Intersection of Ave. Portola & Columbus at Highlands

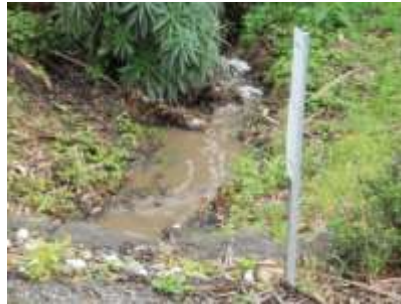
Photo 27 - Runoff from large pipe & culvert under Columbus at intersection with Ave. Portola

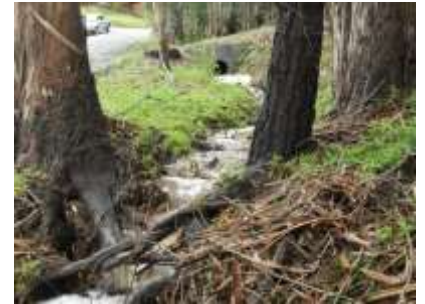
Photo 28 - Deep open-air ditch down Ave. Portola from Columbus

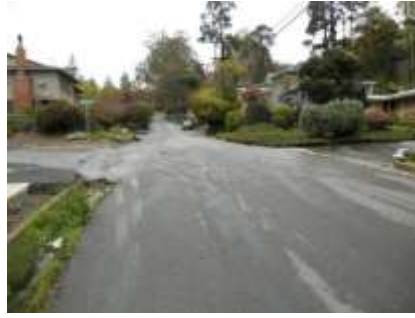
Photo 30 - Flooding down open-air ditches and over x-street Francisco (looking up Ave. Portola)

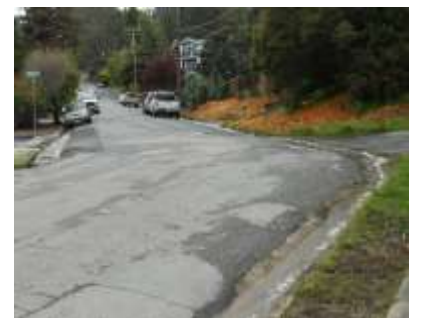
Photo 31 - Flooding down open-air ditches and over x-street Palma (looking up Ave. Portola)

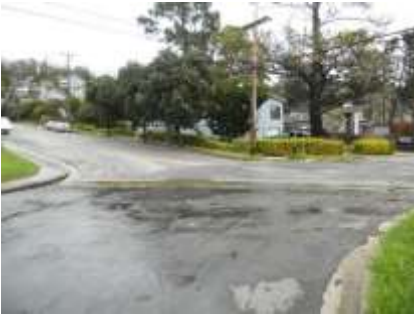
Photo 32 - Flooding down Ave. Portola to and over intersection with The Alameda

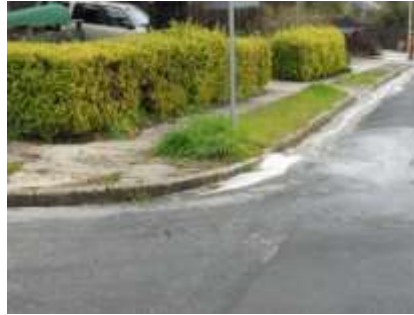
Photo 33 - Flooding from Ave. Portola down The Alameda towards Isabella

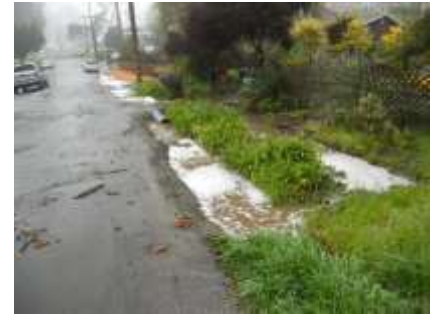
Photo 34 - Flooding continuing down The Alameda to a pipe under its eastern side

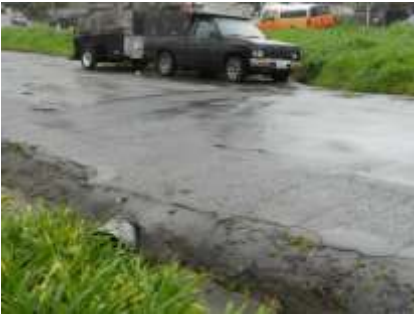
Photo 35 - Pipe under eastern side of The Alameda to culvert in median

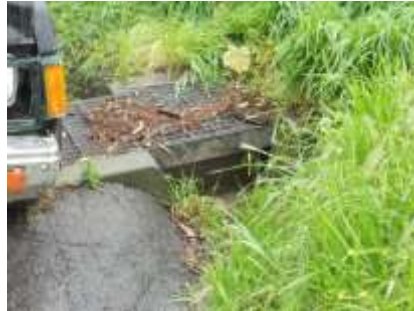
Photo 36 - Culvert in The Alameda's median

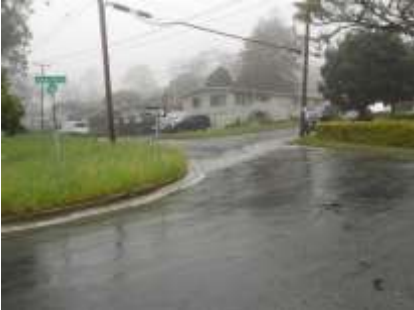
Photo 37 - Additional flooding continuing down from Ave. Portola over the intersection with The Alameda

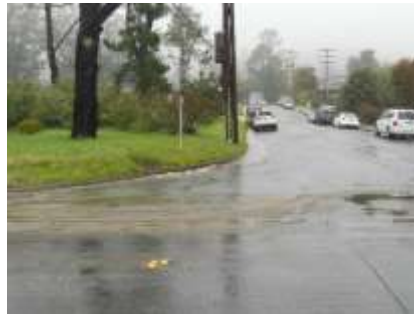
Photo 38 - Flooding continuing down Ave. Portola (over x-street Coronado in distance) to underground storm system storm grate at Ave. Alhambra

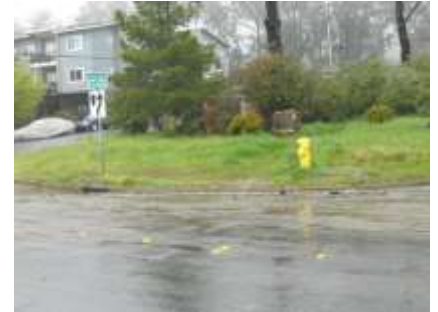
Photo 39 - Flooding down Ave. Portola to underground storm system storm drain at Ave. Alhambra

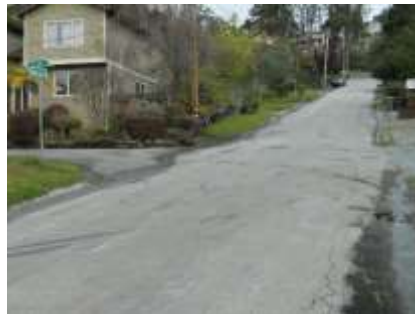
Photo 41 - Runoff down open-air ditches & over x-street Ferdinand (looking up Ave. Del Oro)

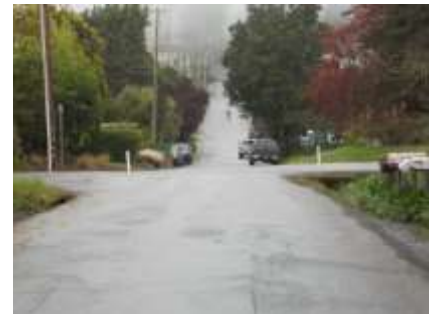
Photo 42 - Runoff down open-air ditches & under x-street Francisco (looking up Ave. Del Oro)

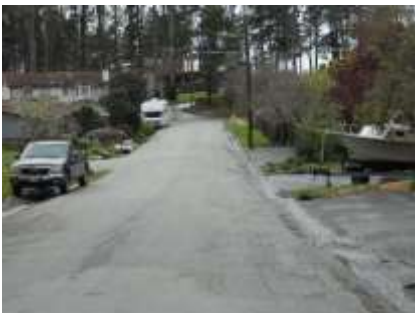
Photo 43 - Runoff down open-air ditches & under x-street Palma (looking down Ave. Del Oro)

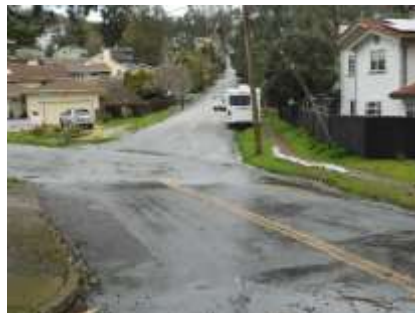
Photo 44 - Runoff down Del Oro to convergence with runoff down San Carlos at The Alameda

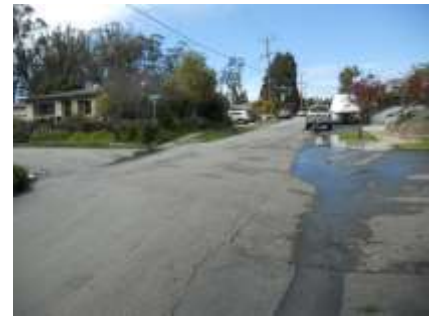
Photo 47 - Runoff down San Carlos and over x-street Francisco (looking up San Carlos)

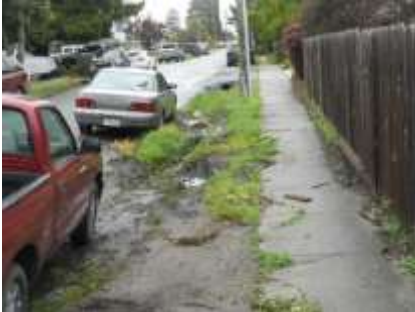
Photo 48 - Continuing runoff looking up San Carlos towards Francisco

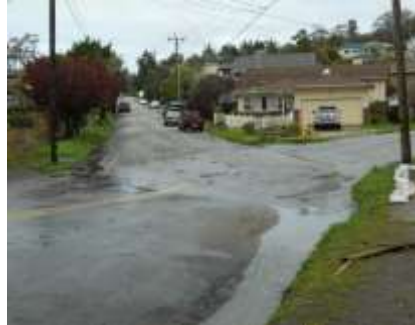
Photo 49 - Runoff down San Carlos to convergence with runoff down Ave. Del Oro at The Alameda

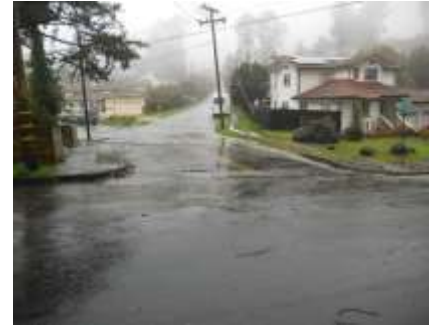
Photo 50 - Runoff down Ave. Del Oro & San Carlos converging to flood down to and across The Alameda

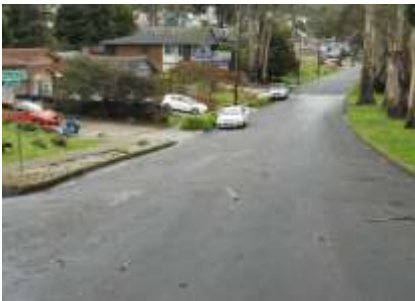
Photo 51 - Flooding down The Alameda from the convergence of Ave. Del Oro & San Carlos runoff

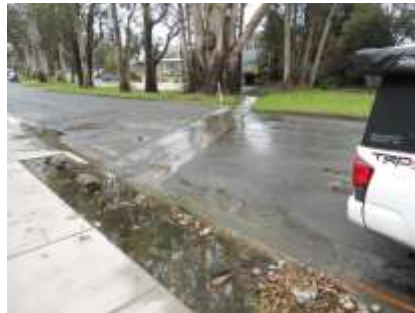
Photo 52 - Flooding over the eastern side of The Alameda to its median

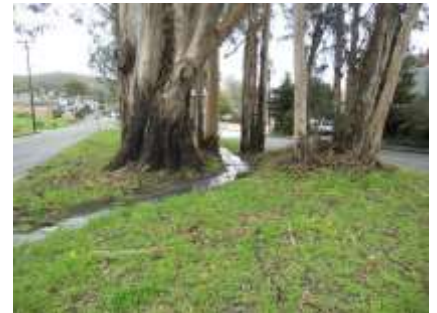
Photo 53 - Diagonal open-air ditch in The Alameda's median

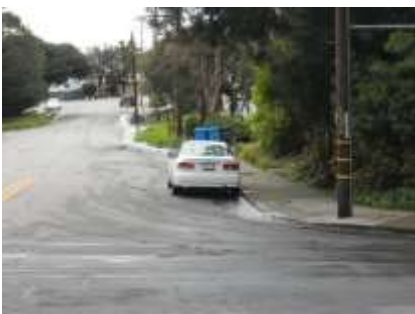
Photo 54 - Flooding over the western side of The Alameda to lower Ferdinand from the median ditch (towards Ave. Alhambra)

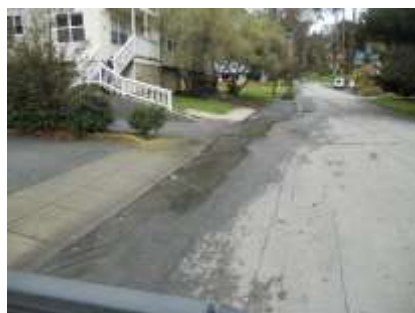
Photo 55 - Flooding down Ferdinand and over x-street Coronado (looking up Ferdinand)

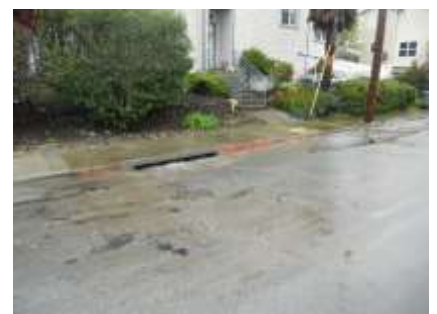
Photo 56 - Flooding down Ferdinand to underground storm system storm drain at Ave. Alhambra

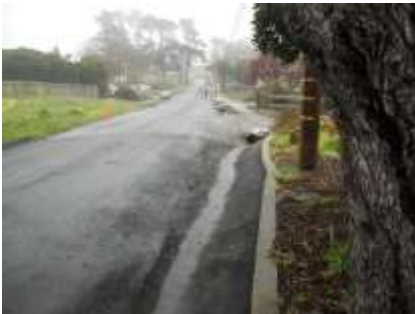
The stormwater runoff flooding down Sonora from Ave. Granada appeared to consist of street runoff from Sonora as well as runoff from the convergence of Ave. Granada, Madrona Ave, and Almeria Ave. supplemented by runoff from Solano Ave. The individual runoff of the three converging streets did not appear significant in the March '23 storm until combined. This combined runoff, supplemented by runoff down Solano, then flooded down Ave. Granada in deep open-air ditches occasionally passing through pipes under sandbagged residential driveways and flooding into Sonora (3 residential blocks, approx. 900 linear ft.) (see Photos 57 & 58). Once at Sonora, the flooding stormwater flowed from Ave. Granada over Sonora cross streets Sevilla Ave, Madrid Ave, and Presidio Ave. into the underground storm system storm drain at the westerly end of Sonora towards Hwy 1 (4 residential blocks, approx. 1,200 linear ft.) near where it curves toward Coral Reef Ave. (see Photos 59 to 64). [Flooding from the large pool of stormwater runoff, on the north-east of the curve behind homes on Sonora, to the underground storm system storm drain is shown in Photos 64 to 67.]

Photo 57 - Runoff from convergence of Ave. Granada, Madrona, & Almeria down Ave. Granada towards Sonora

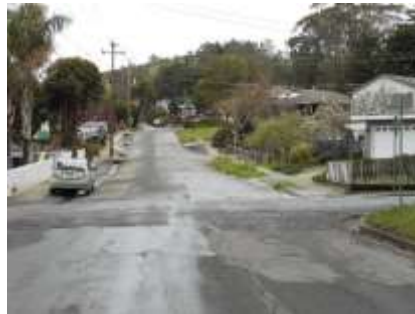
Photo 58 - Runoff from convergence down Ave. Granada plus runoff from Solano at intersection of Sonora & Ave. Granada

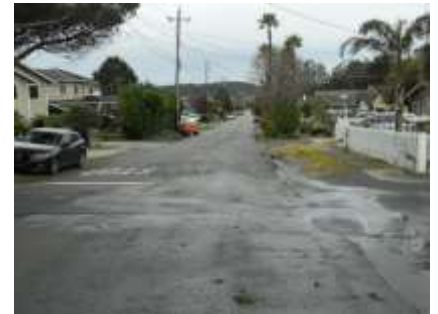
Photo 59 - Combined runoff from Ave. Granada flooding down Sonora at intersection of Sonora & Ave. Granada

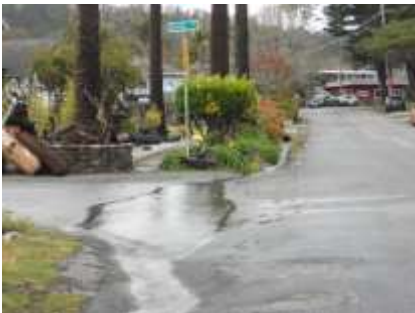
Photo 60 - Flooding down Sonora over x-street Sevilla (towards Ave. Granada)

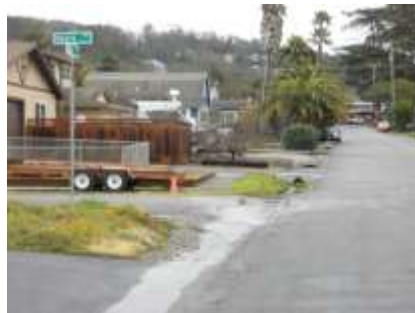
Photo 61 - Flooding down Sonora over x-street Madrid (towards Ave. Granada)

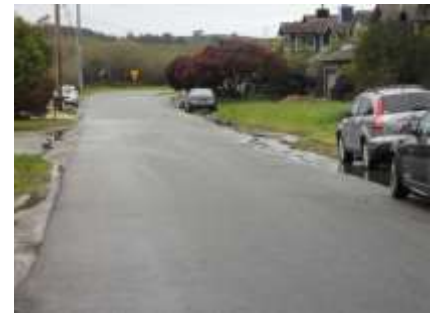
Photo 62 - Flooding down Sonora over x-street Presidio (towards storm drain)

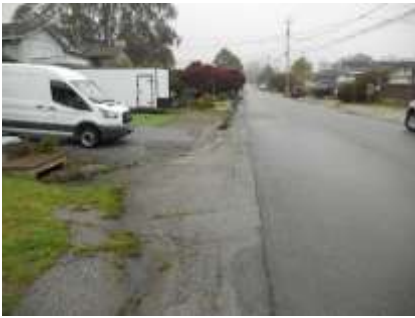
Photo 63 - Flooding down Sonora to the storm drain looking towards Presidio

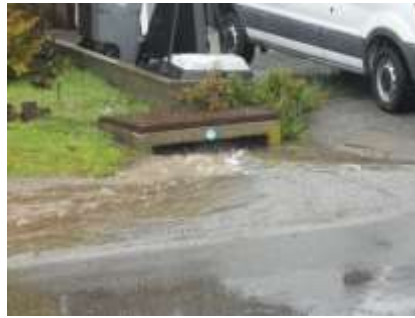
Observation of March '23 stormwater runoff on Sonora Ave<sup>21</sup> showed flooding runoff from two opposite directions. The single underground storm system storm drain located at the end of Sonora near where it curves towards Coral Reef Ave. was receiving flooding runoff from both its right as well as left sides (see Photo 64). Runoff was flooding not only down Sonora from Ave. Granada to the drain (see Photos 57 to 64) but also beyond the drain from the curve back to the drain (see Photo 65). The source of the flooding back to the drain was a large pool of stormwater runoff on the north-east of the curve behind a number of residences (see Photos 66 & 67). Runoff overflow from that pool not only flooded into the storm drain but also flooded the entire roadway at the curved portion of

Sonora (see Photos 64 to 67). The area with the pool behind the homes was discovered to be wetlands (see Photos 67 to 69).

Photo 64 - Flooding from both sides into underground storm system storm drain at the westerly end of Sonora before where it curves toward Coral Reef

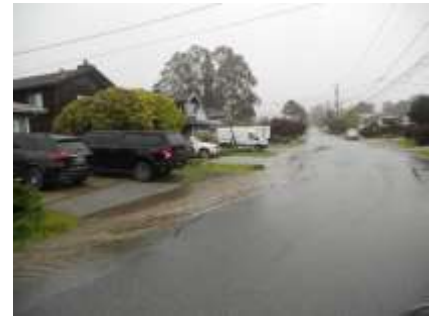
Photo 65 - Flooding on Sonora from stormwater pooling at the curve back to the storm drain

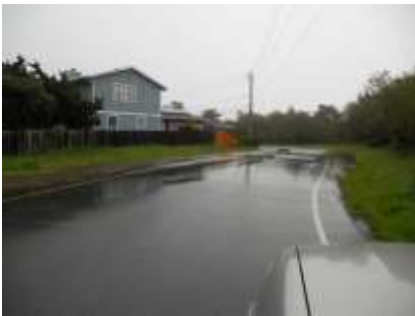
Photo 66 - Pooling runoff flooding the entire roadway at the curved portion of Sonora (towards the storm drain)

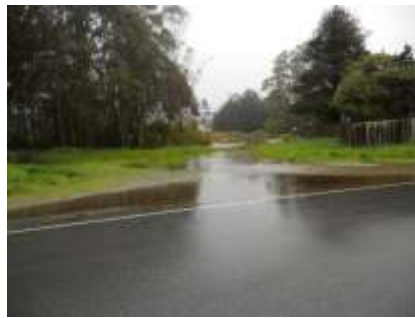
Photo 67 - Large pooling of stormwater runoff behind homes flooding onto Sonora beyond its curved portion (Coral Reef is to the left)

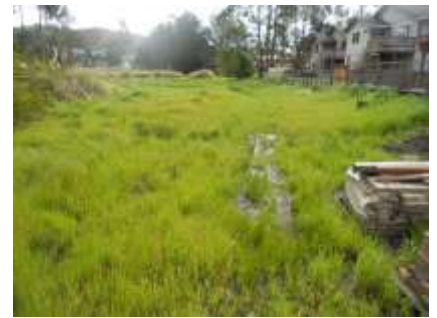
Photo 68 - Wetlands behind homes at storm pooling site (4/15/2023)

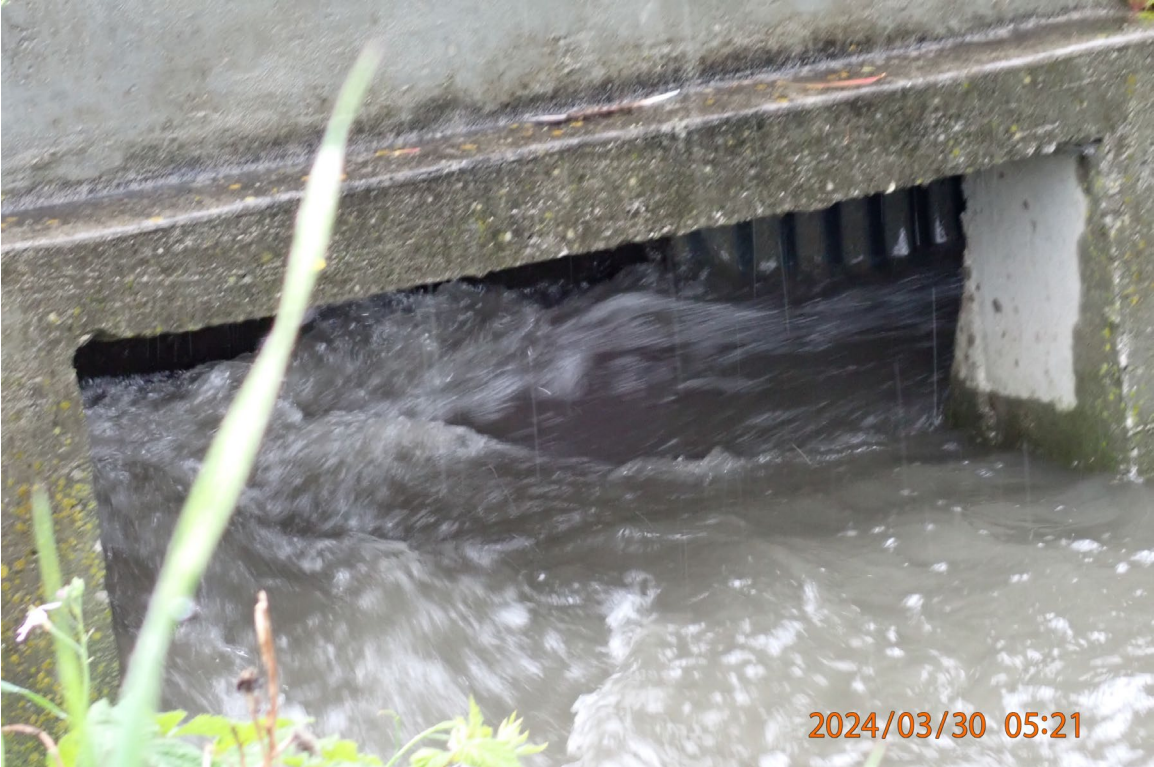
**Figure 5** Outlet from the two parallel 25" culverts under Highway 1

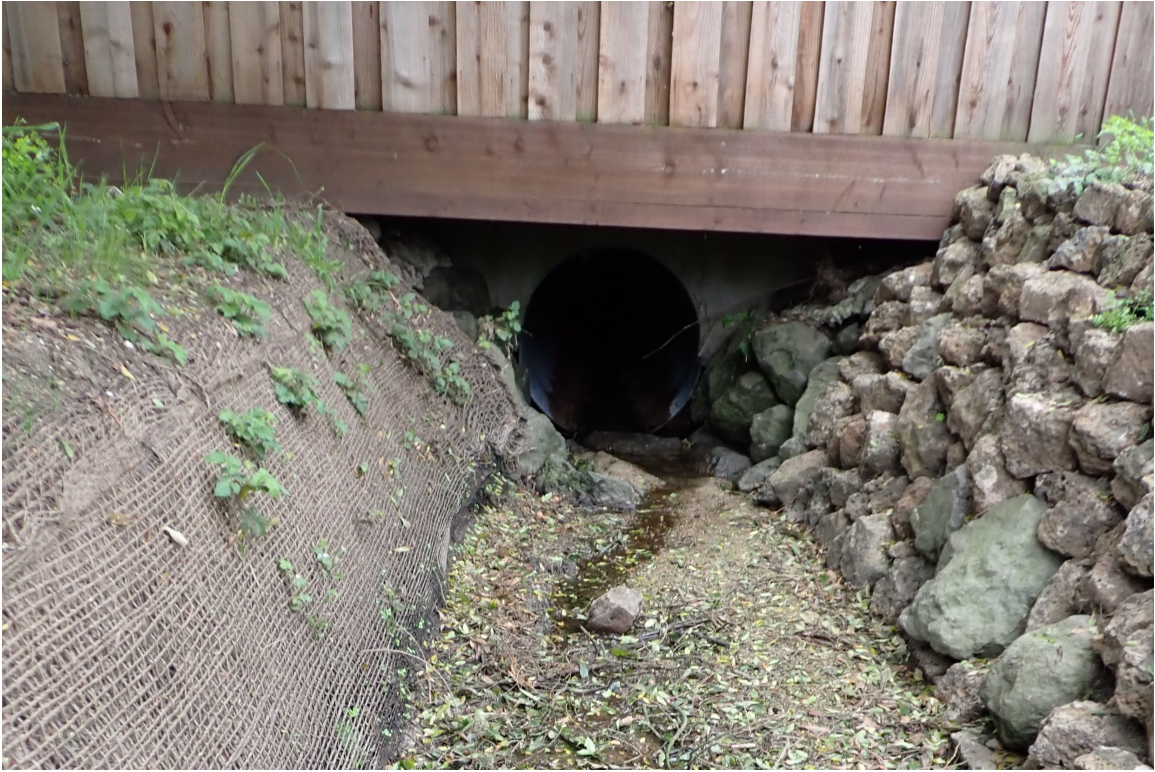
**Figure 6** Outlet from the two parallel 25" culverts under Highway 1

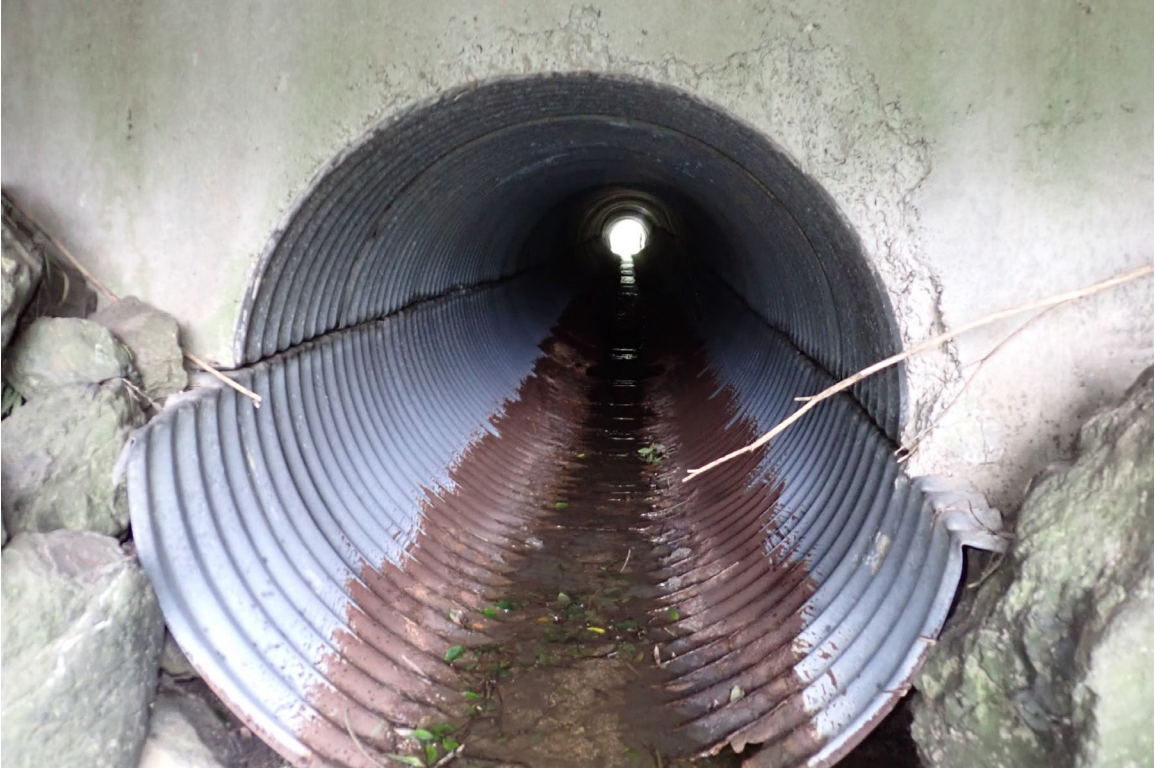
**Figure 7** Inlet to 36" culvert under 2805 Alameda Ave

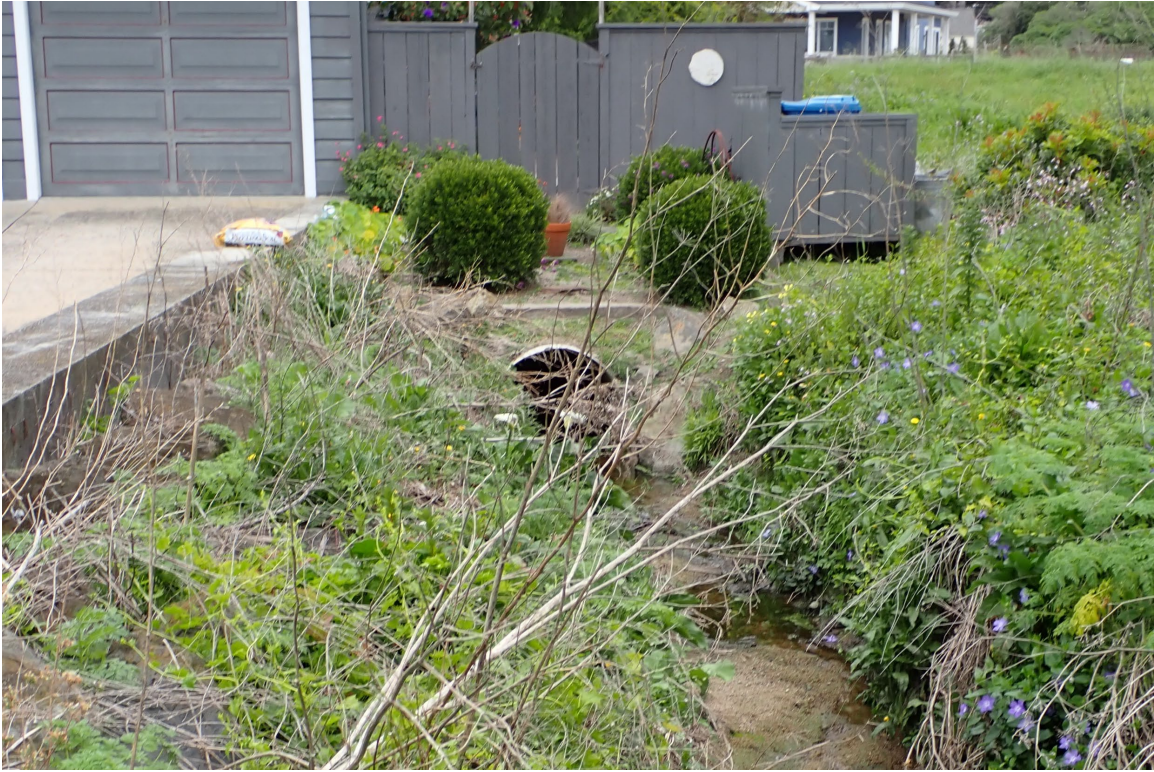
**Figure 8** Inlet to 36" culvert under 2805 Alameda Ave

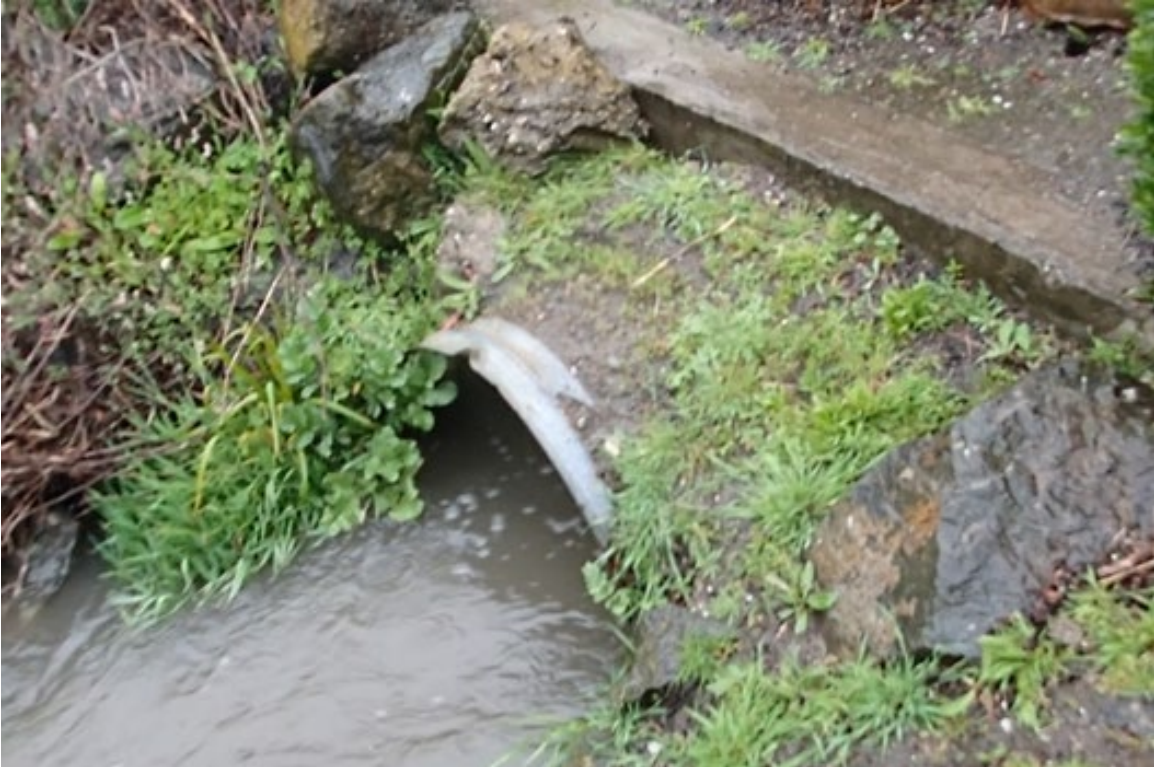
**Figure 9** Outlet of 36" culvert under 2805 Alameda Ave

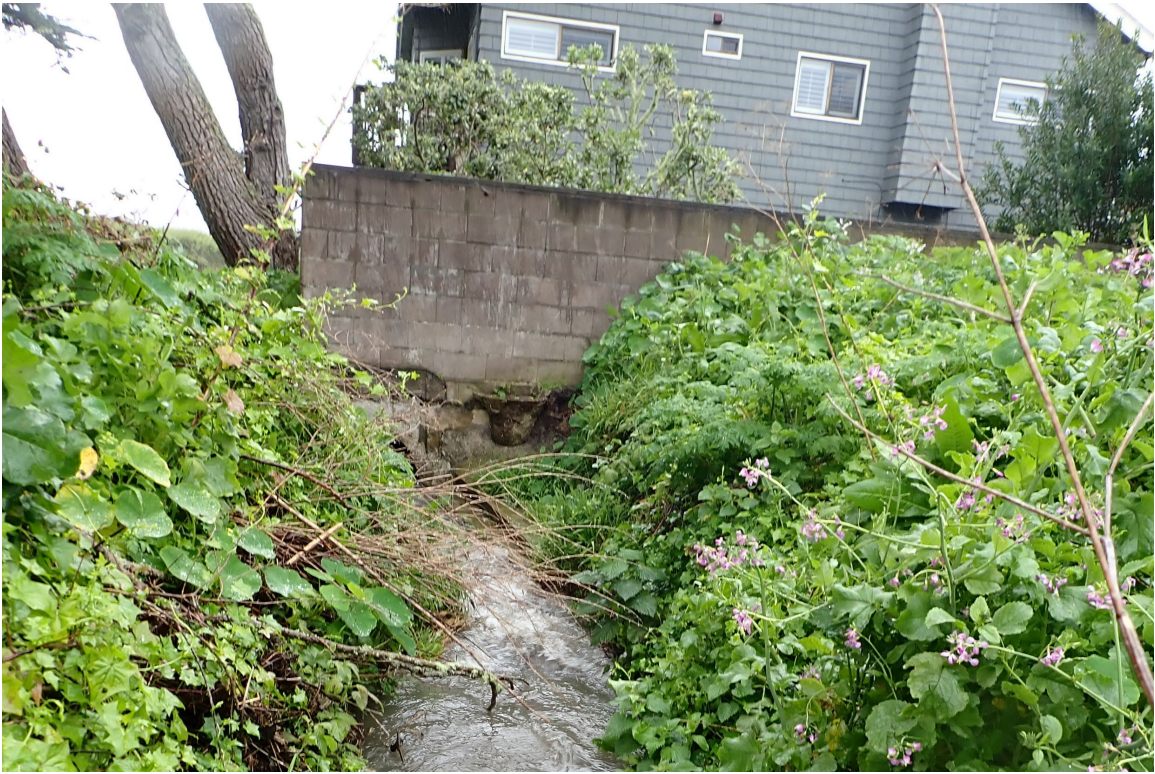
**Figure 10** Outlet of 36" culvert under 2805 Alameda Ave

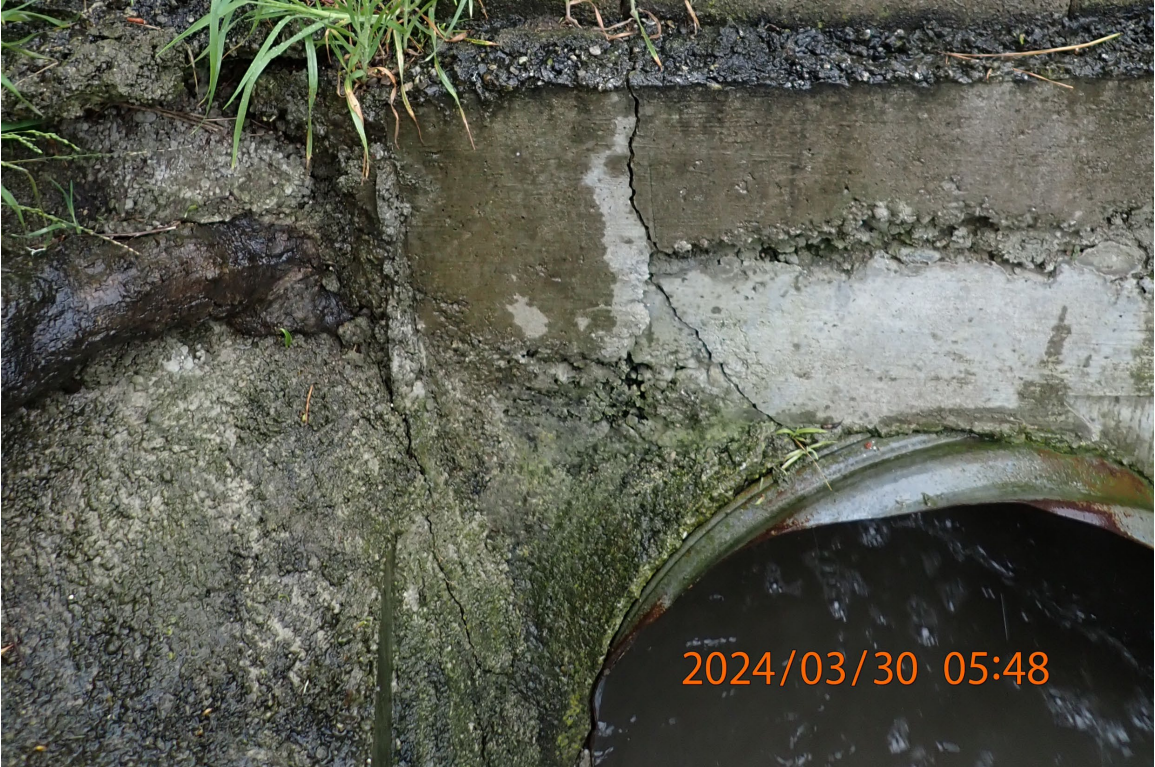
**Figure 11** Inlet to 29" culvert under 2805 Naples Ave

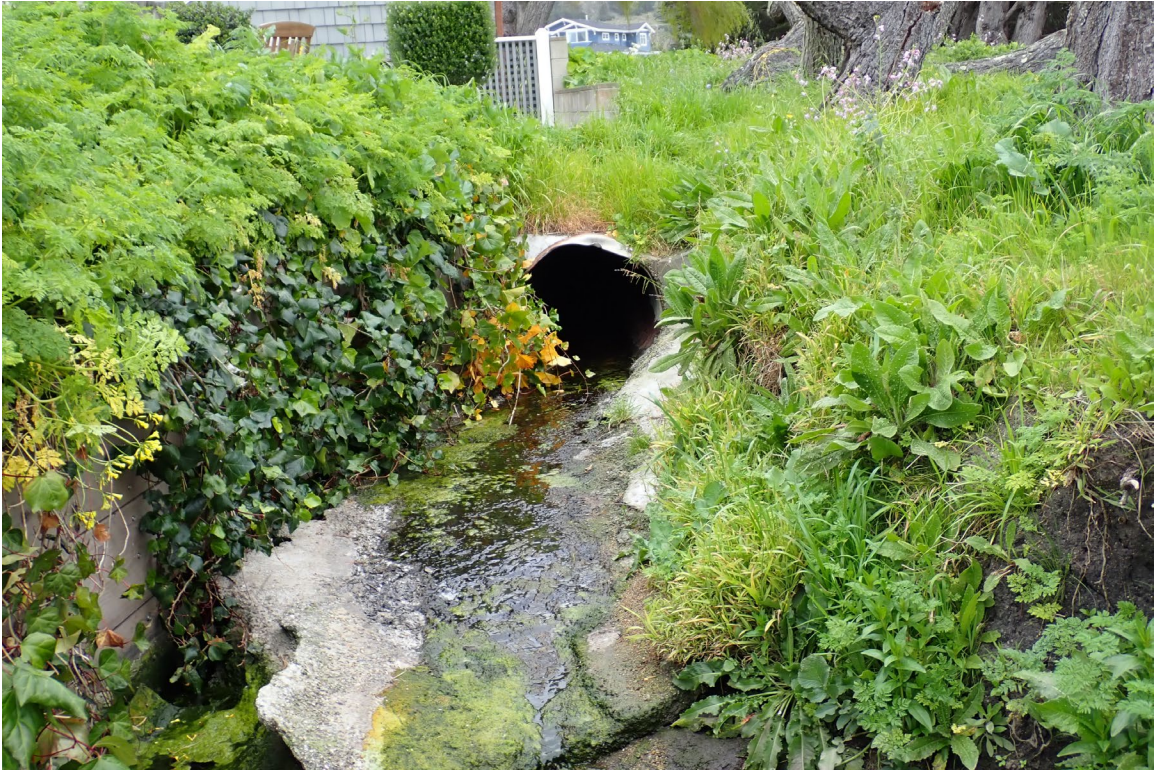
**Figure 12** Inlet to 29" culvert under 2805 Naples Ave

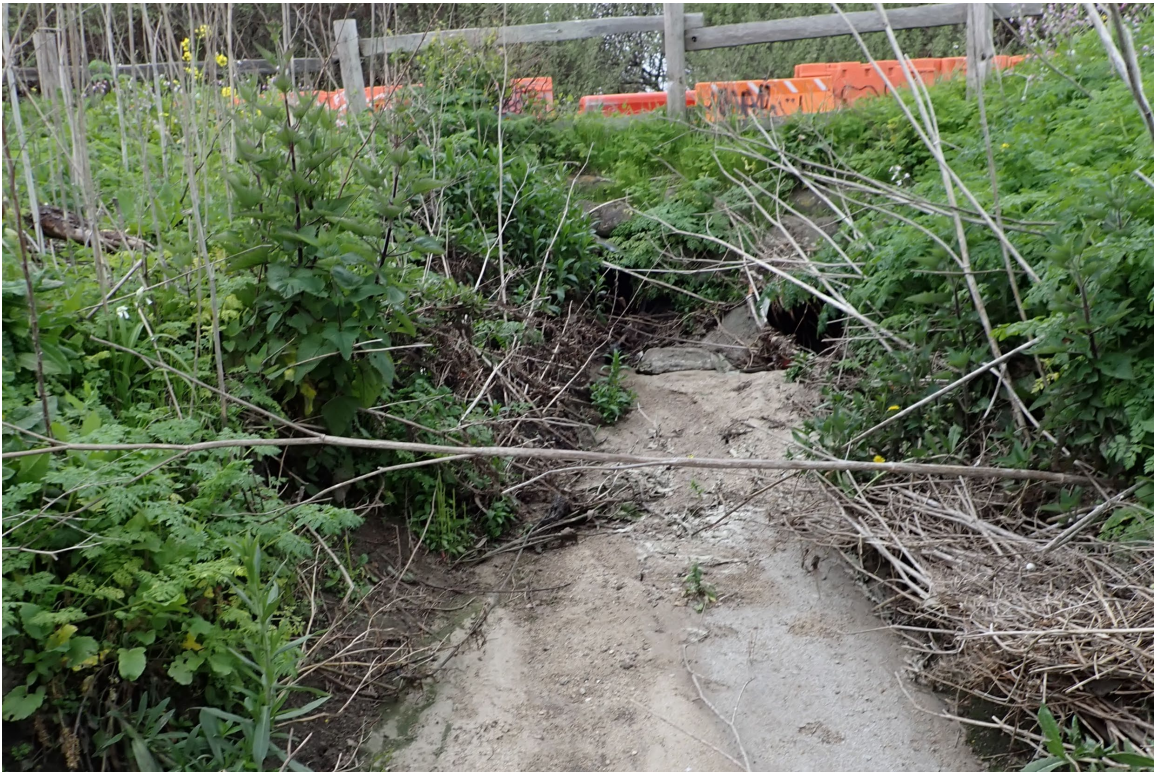
**Figure 14** Interior of 29" culvert under 2805 Naples Ave, viewed from outlet

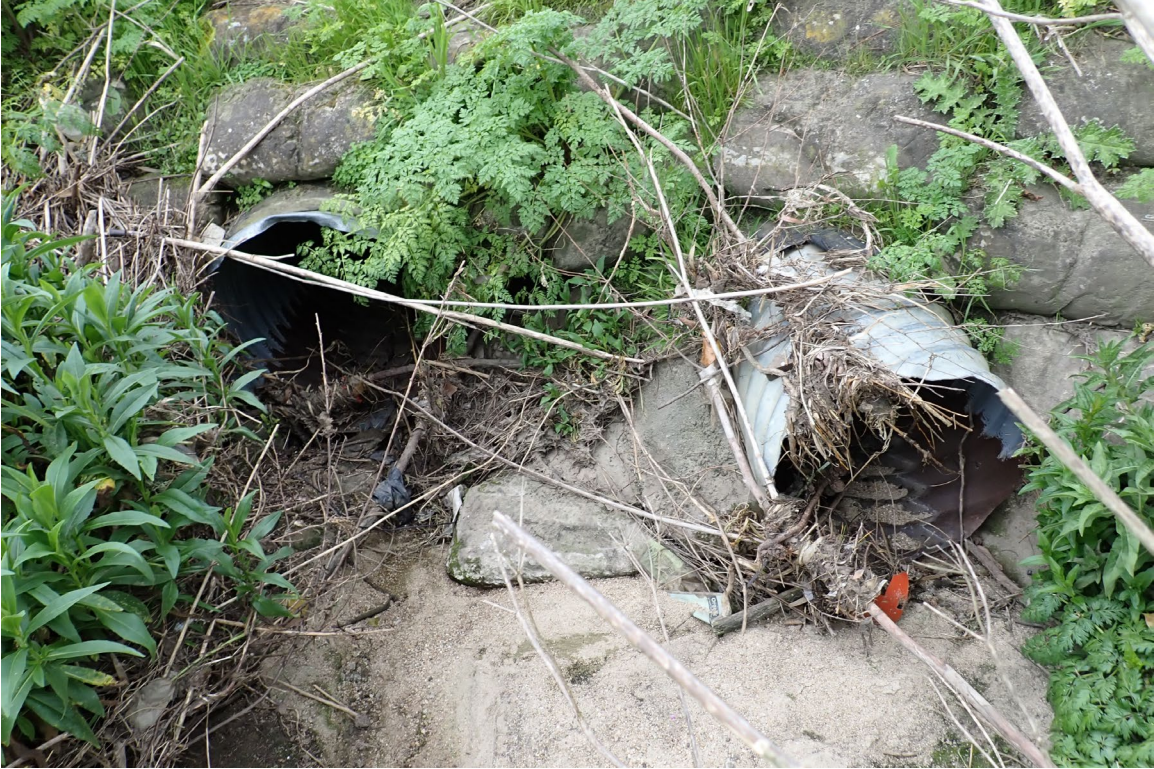
**Figure 15** Inlet to parallel 17" and 24" culverts under Coastal Trail

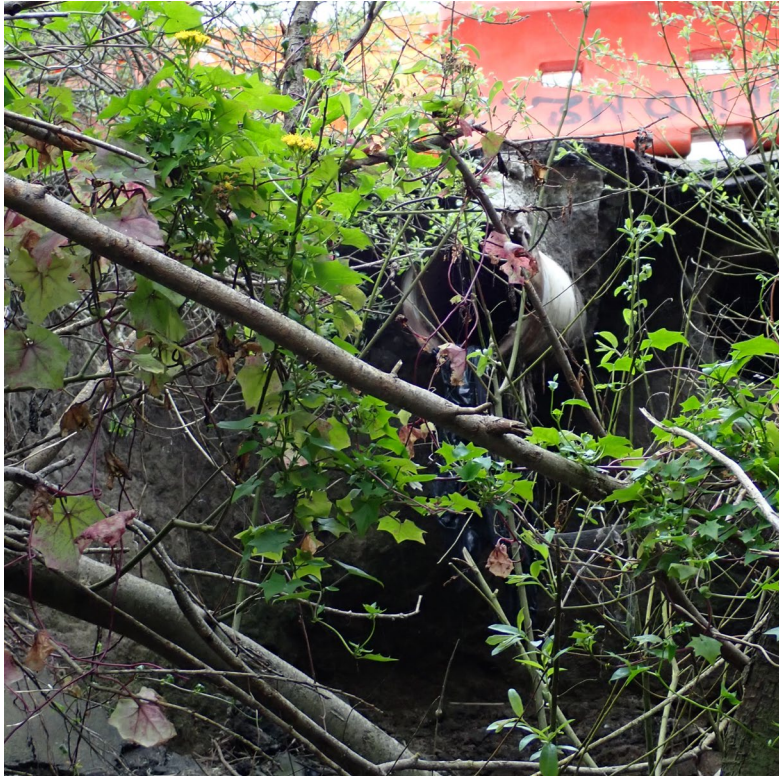
**Figure 16** Inlet to parallel 17" and 24" culverts under Coastal Trail
