# Flooded With Problems

## Stormwater Management on the SMC Coast Situation, Causes, Solutions and Recommendations

Agency Review Draft - Jan. 8, 2025

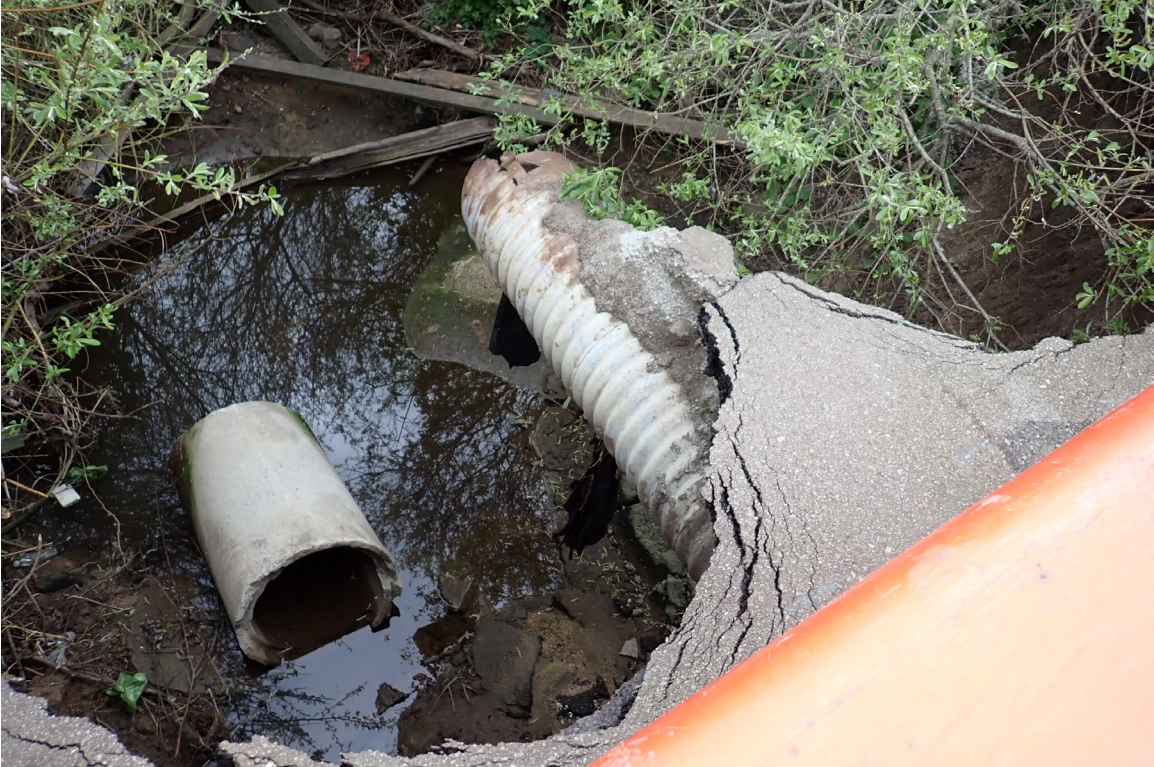
**Figure 17** Outlet from parallel 17" and 24" culverts under Coastal Trail

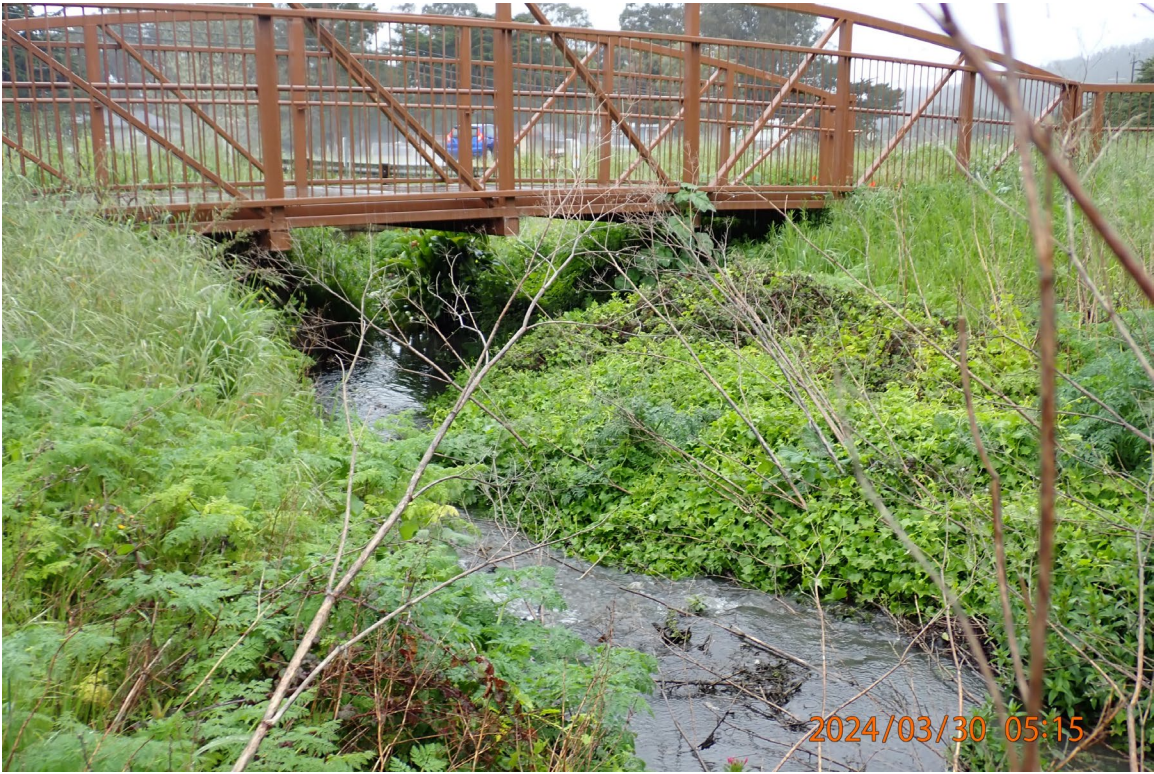
Bridges crossed the Ditch northeast of the Highway 1 inlet, at Pullman Avenue, and at Champs Elysee Avenue (Figures 19 through 21). The majority of the open channel portions of the Ditch were vegetated earthen channels with irregular cross section (Figures 22 through 24), with a concrete barrier bordering the northeast bank at the end of Alameda Avenue (Figure 25), a concrete bank wall upstream of 2805 Naples Avenue (Figure 26), an irregular poured concrete outlet apron downstream of 2805 Naples Avenue (Figure 27), and a timber retaining wall on the northeast bank at the 2805 Naples Avenue outlet (Figures 13 and 28). Downstream of the culvert crossing under 2805 Naples Avenue, soil loss was visible behind the timber retaining wall (Figure 29) and under the concrete apron (Figure 27). The section of the Ditch fronting the Rossi Residence had more uniform trapezoidal cross section than other open channel reaches of the Ditch, with rock armoring on one bank and jute netting on the other (Figure 30).

**Figure 18** Outlet from parallel 17" and 24" culverts under Coastal Trail

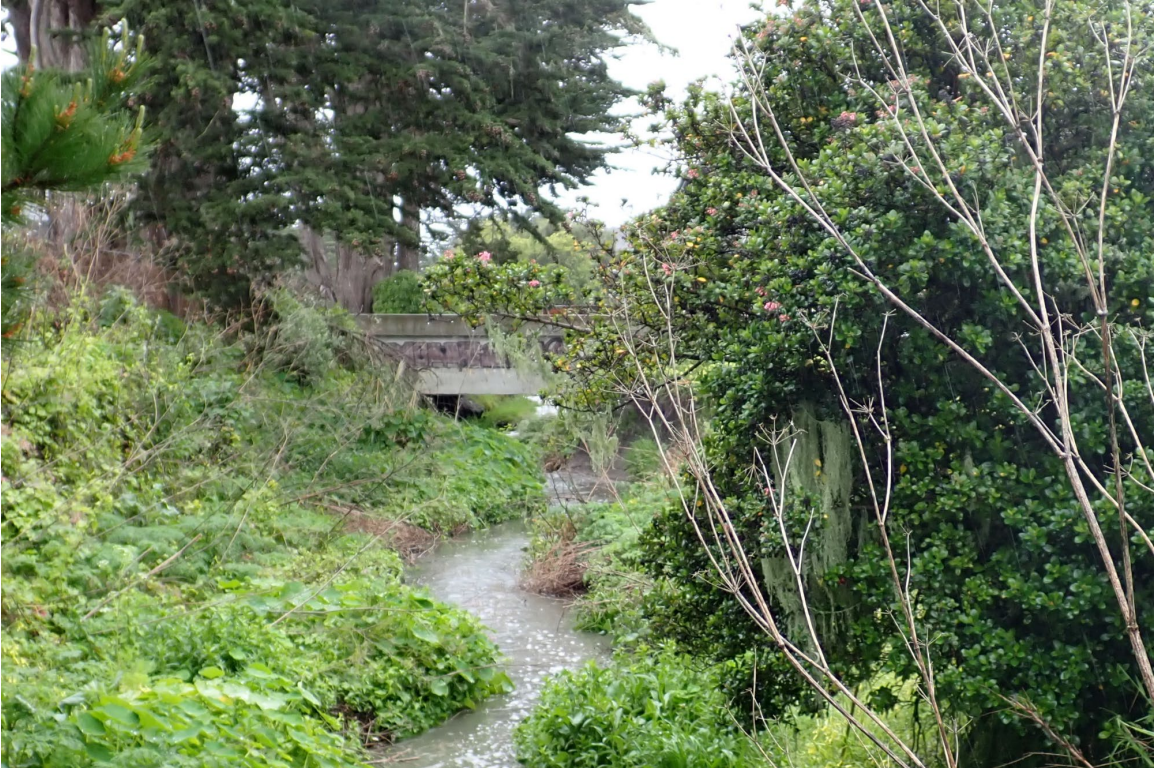
**Figure 19** Pedestrian bridge northeast of Highway 1

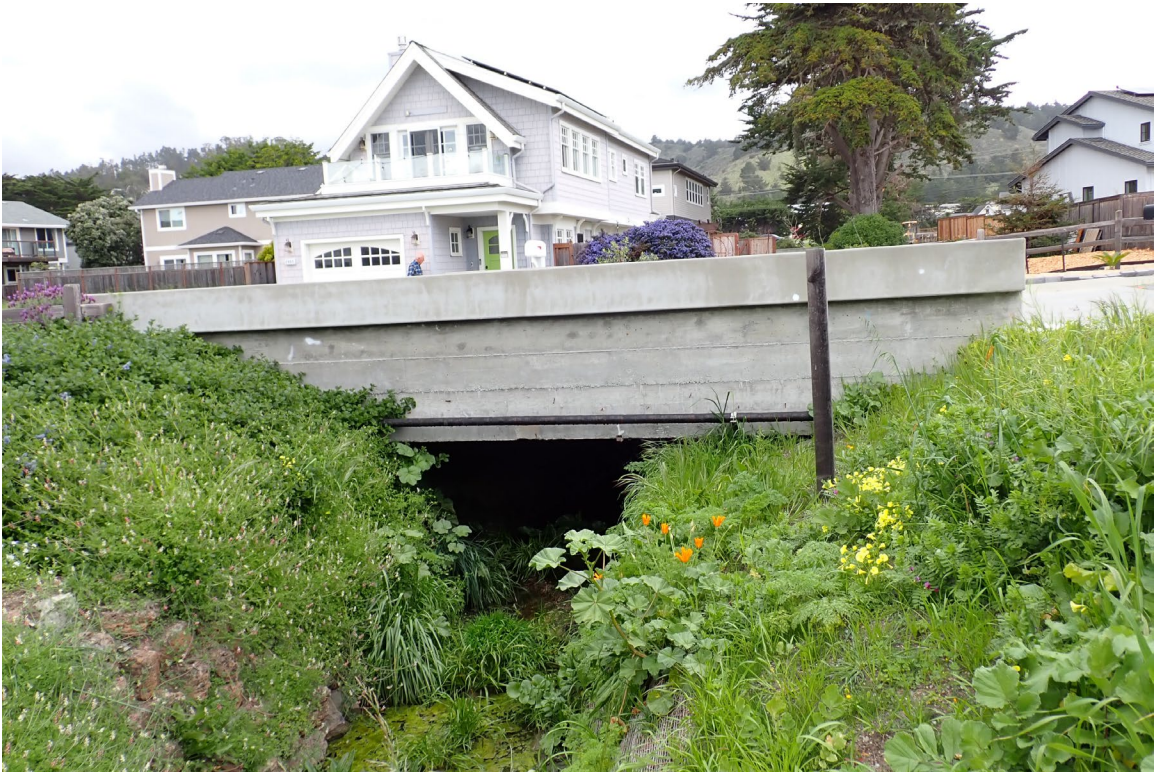
**Figure 20** Pedestrian bridge at Pullman Ave

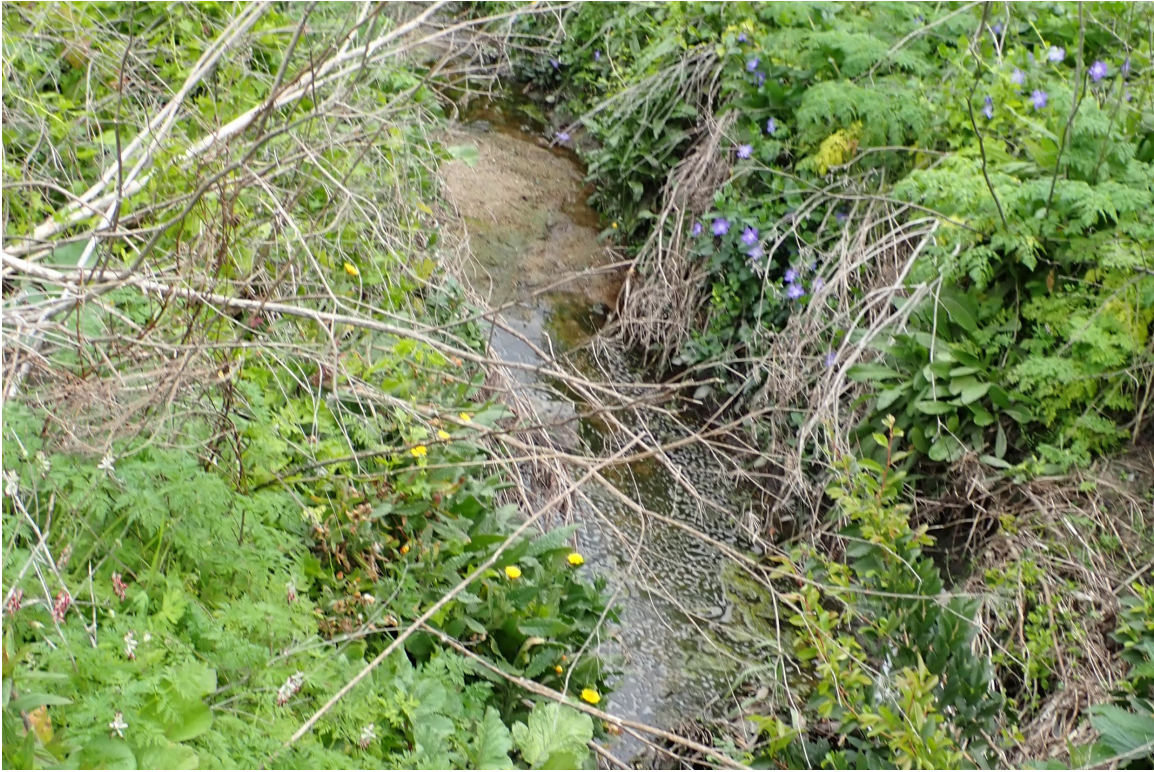
**Figure 22** Pullman ditch between Highway 1 and Pullman Ave, 3/29/24 rain

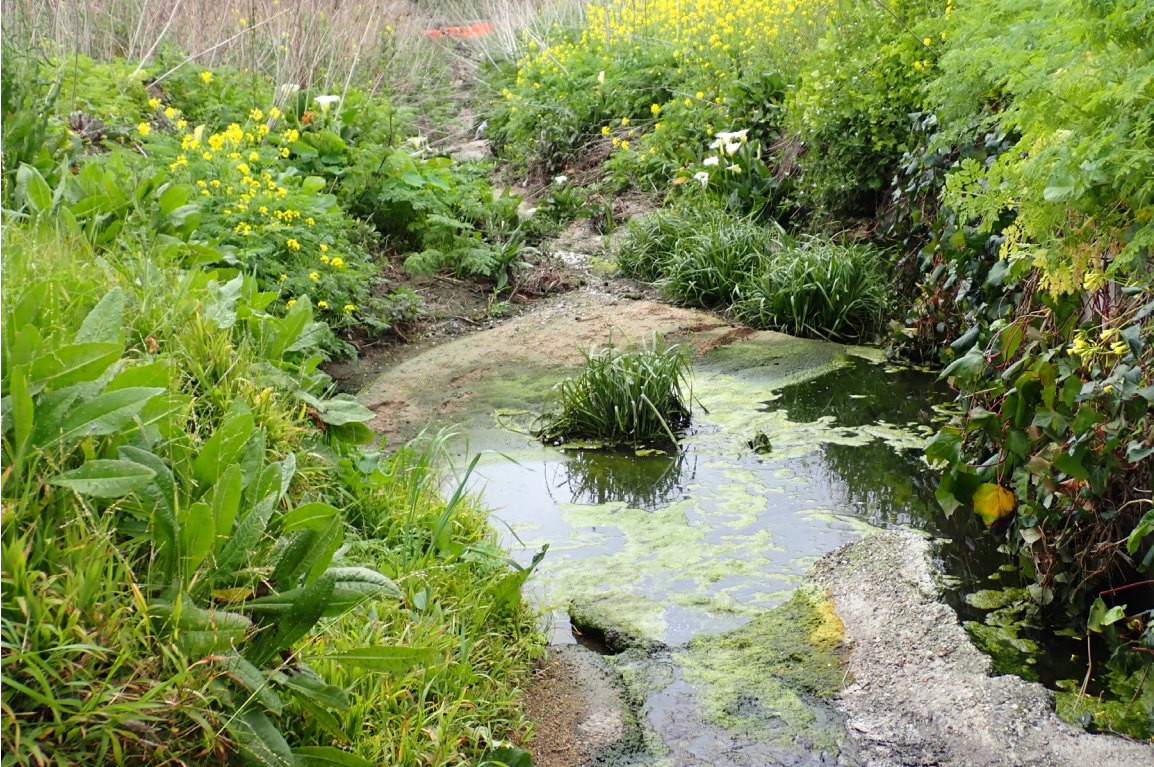
**Figure 23** Pullman ditch between Alameda and Naples Ave, dry weather

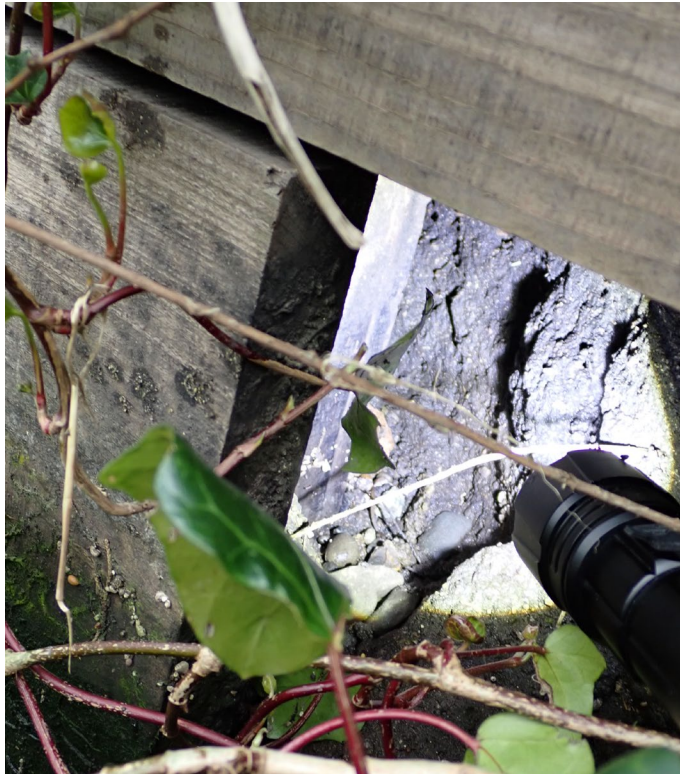
**Figure 28** Timber retaining wall downstream of 2805 Naples Ave, downstream end

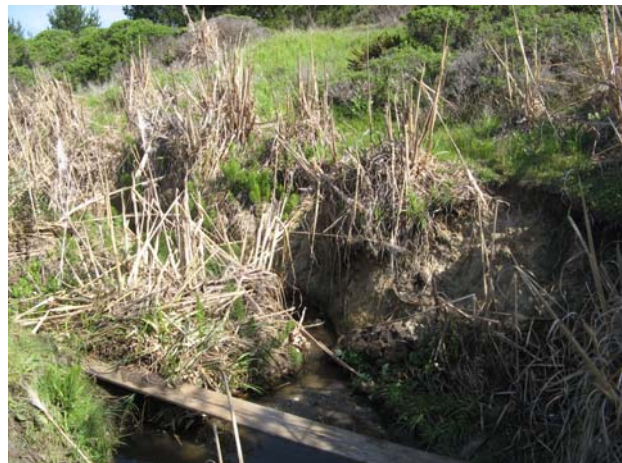
Photo 3. Photo taken just north of and across 2<sup>nd</sup> Street from Photo 2, showing the riparian area and open space/upland habitat beyond. Note that the area is severely gully, and that the large dead grasses are nonnative Pampas grass.

riparian area is an upland area which forms a direct connection to the open space described in the paragraph above. That creek is within the County's road right-of-way and the historic channel was probably where 2<sup>nd</sup> Street currently exists. As shown in Photos 2 and 3, there are gullies on either side of the street at the top of 2<sup>nd</sup> Street at East Avenue. The riparian area on the northern side of 2<sup>nd</sup> Street has been disturbed in the past, probably as a result of the construction of 2<sup>nd</sup> Street and the houses that are located on the southern side of the street. One home is located on the northern side of the street, but the other lots are undeveloped. 2<sup>nd</sup> Street in this block is considered by San Mateo County to be an "unimproved paper street" and as such is not maintained by the County. It is surfaced with gravel and appears to have been chip sealed in the past. As shown in Photo 1, the topography in this area slopes northwest from East Avenue to Kanoff Street.

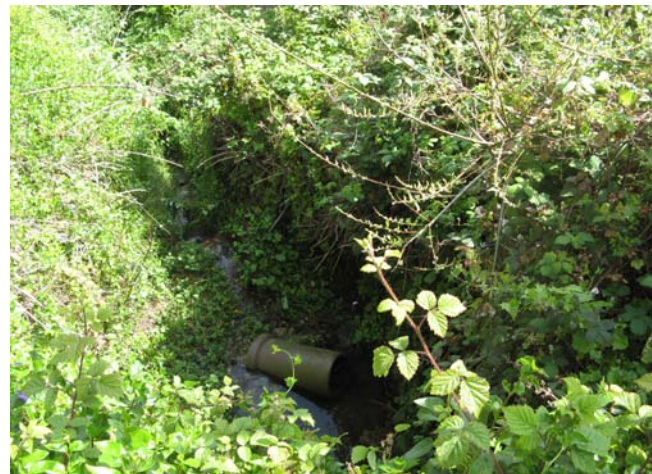
**Photo 4.** Channelized drainage ditch at the corner of Kanoff and 2<sup>nd</sup> Street. This reach is dominated by nonnative plant species.

At the corner of 2<sup>nd</sup> Street and Kanoff Street, the drainage ditch is channelized into a concrete “U” shaped ditch (see Photo 4). This reach is downstream of the area that contains the arroyo willow and ruderal vegetation. The vegetation in this reach is dominated by nonnative, invasive plants such as blackberry (*Rubus discolor*), German ivy, periwinkle (*Vinca minor*), and Algerian ivy (*Hedera helix*), has little habitat value, and there is no natural drainage channel.

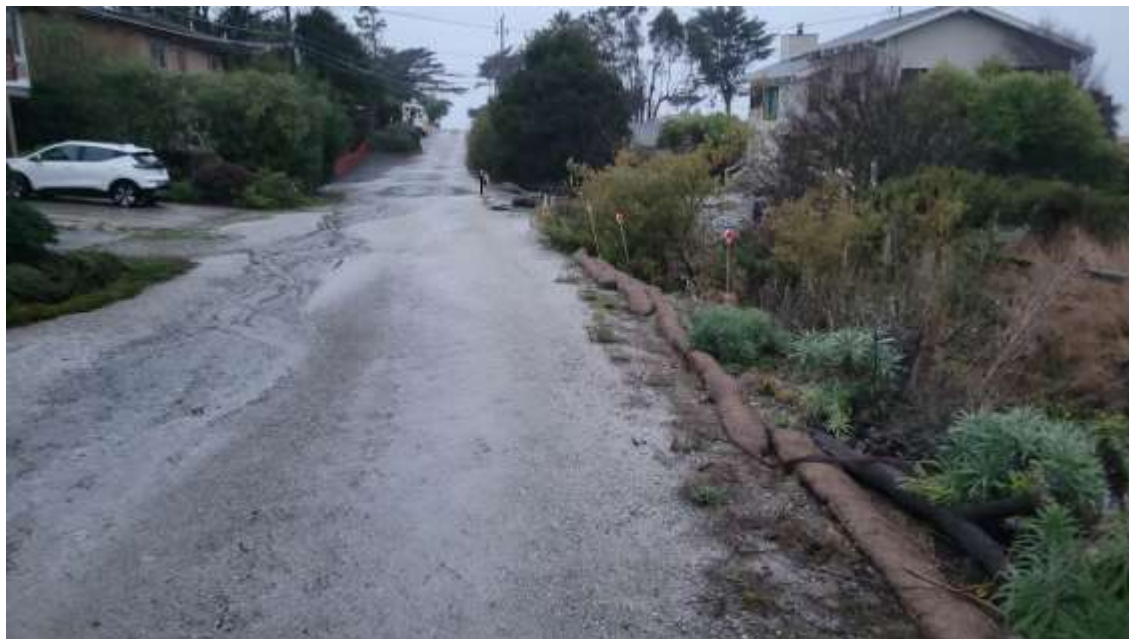
Photo 1. Rilling and creekbank erosion on 2nd Street. Channel incision and bank erosion have eroded the roadway embankment on north side of road. Lack of proper engineering of roadway causing rilling of roadway. View is looking west (downstream).  
Photo date: 11-22-2024.

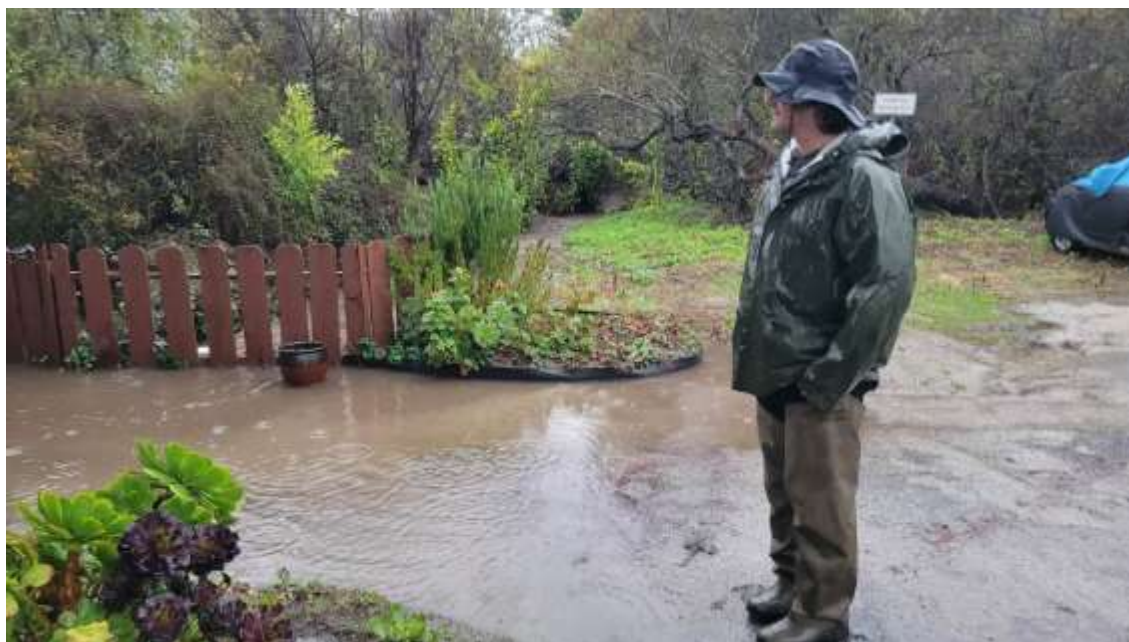
Photo 2. Creek overflow flooding driveway, yard and garage at 280 Kanoff Street. View is looking west (downstream). Photo date: 11-22-2024.

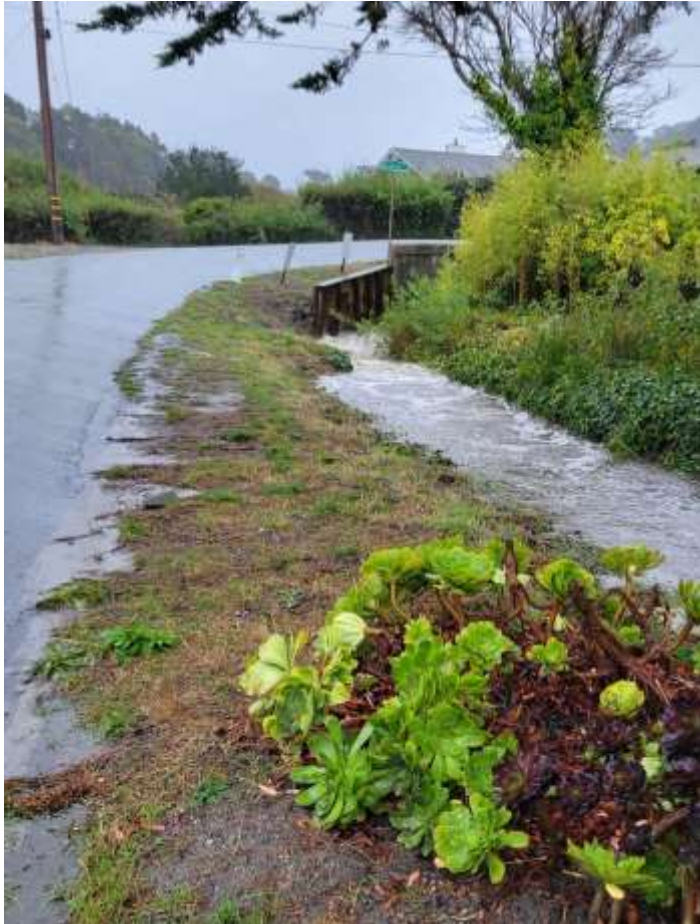
Photo 3. Creek at bankfull, after overtopping at 280 Kanoff Street. View is looking east (upstream) towards intersection of Farallone Street and Kanoff Street. Photo date: 11-22-2024.
