# Flooded With Problems

## Stormwater Management on the SMC Coast Situation, Causes, Solutions and Recommendations

Agency Review Draft - Jan. 8, 2025

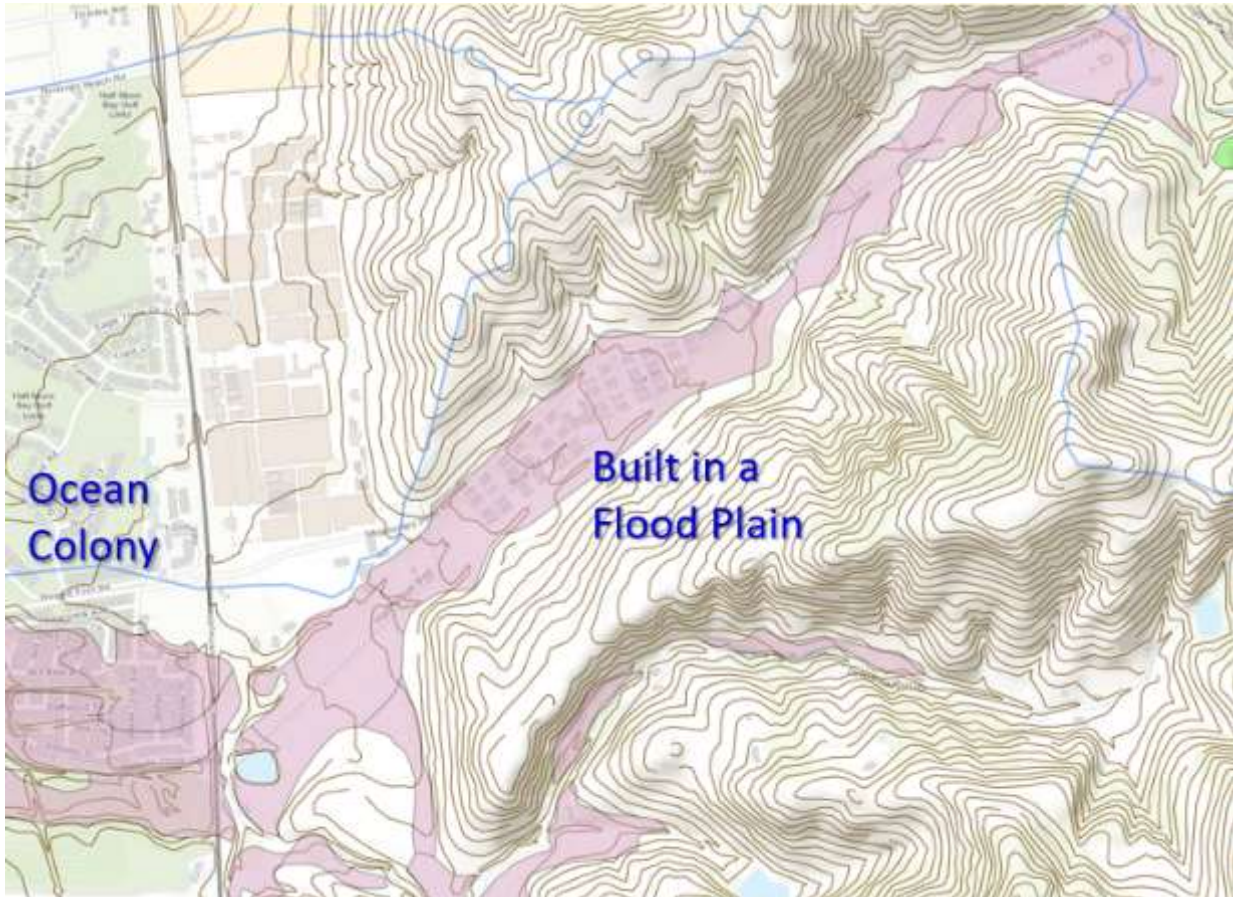
Moonridge was built in a flood plain, as shown in the map. We toured the site with then-Vice Mayor of HMB Joaquin Jimenez. He showed us a large gash on the hillside north of Miramontes Point Road, near the East end of the housing complex. Water had spilled down from that hill, flooded over the road, and entered the “bowl” in which the housing was built. After the storm, Bobcat tractors had been used to scour out a ditch on the north side of the road, to direct water to the west along the road, to

drain away from the housing. In the lawns surrounding the housing units there are small ‘weepholes’ apparently intended to drain water under the housing. They lacked any domed screens to prevent clogging, and were clearly inadequate to the drainage required for that storm. Residents reported frequent flooding in storms. Mr. Jimenez said that one solution discussed was to create a culvert from the rear of the road, running approximately north to south under the road and the lawns, to carry stormwater to a creek on the south side of the complex. At this writing we are unaware of any committed solution, but will update this report as we learn more.

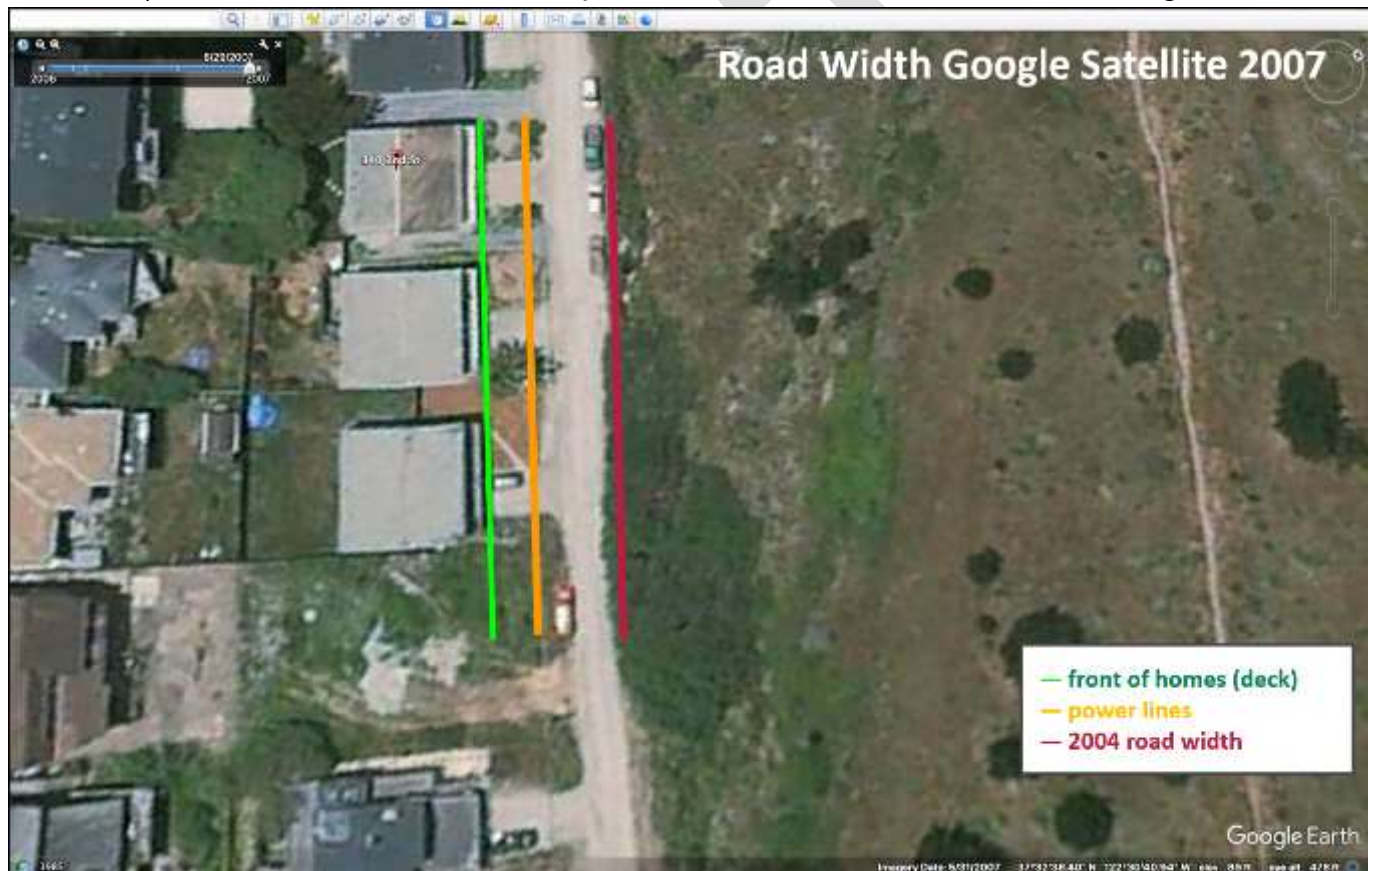
Homes on 2<sup>nd</sup> Street in Montara experience substantial flooding during rainstorms. One resident claims she spent over \$100,000 of her money to protect her house from the upstream flooding which has continued to intensify over the years. The storm flow comes down from the top of the hill on 6<sup>th</sup>. There is no stormwater channel in some sections, which results in deep channeling and runoff down 2<sup>nd</sup>. The width of the road has been narrowed by repeated flooding. To add insult to injury, there is no prepared stormwater channel for the recent new construction on 3<sup>rd</sup>, and the County has approved new construction in this area for 370 2<sup>nd</sup> St. and on 3<sup>rd</sup> Street without acting on the longstanding drainage issues. Since 2005, the increased runoff in, around and over 2<sup>nd</sup> Street has resulted in flooding and monetary damage to 2<sup>nd</sup> Street homes and the primary access road. In Kanoff Creek (aka: The Ditch) there has also been willow expansion, increased sedimentation, and significant road

erosion. These issues are documented in the [Presentation](#) in Exhibit 1 highlighting stormwater issues on 2<sup>nd</sup> Street, Montara.

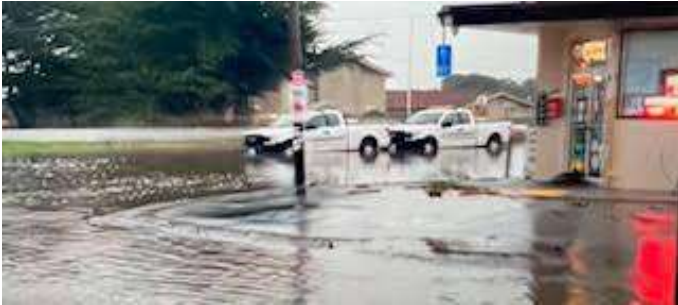
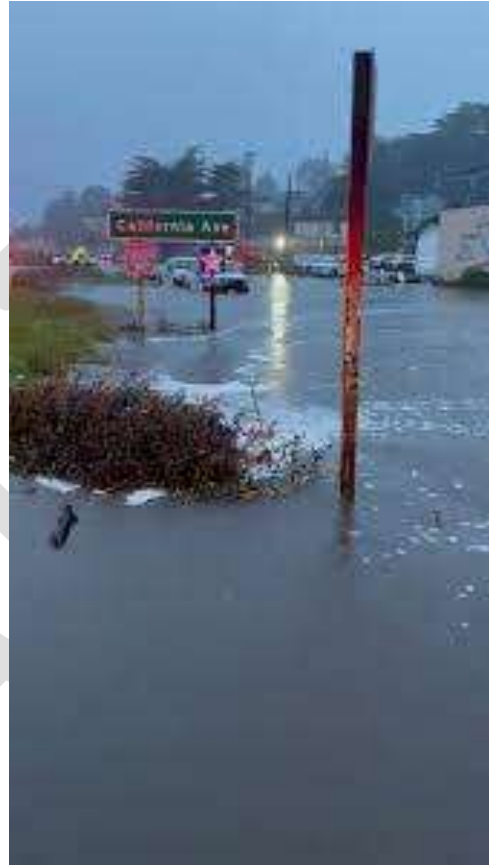
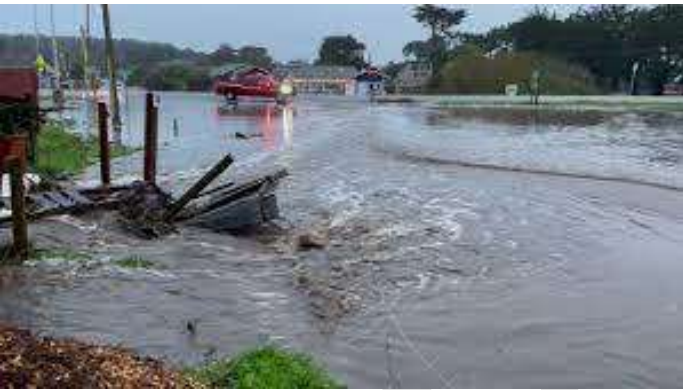
A. As shown in the following pictures from Mar. 12, 2023<sup>43</sup>, the areas adjacent to Hwy 1 in Moss Beach between California and Vermont regularly flood during storms. Water coursing down the hill terrace to the northeast is funneled by Carlos St. and Sunshine Valley Rd. to this area and storm drains have long been insufficient to control the accumulation.

*“These are pictures taken by SAM staff the morning of March 12, '23 [cited above]. Storms flooded north Moss Beach, and the landscape in that area does not appear to have any organized way to manage water accumulation and flow. Excessive water accumulation negatively impacted traffic safety, the MWSD sewer system, private yards and homes....*

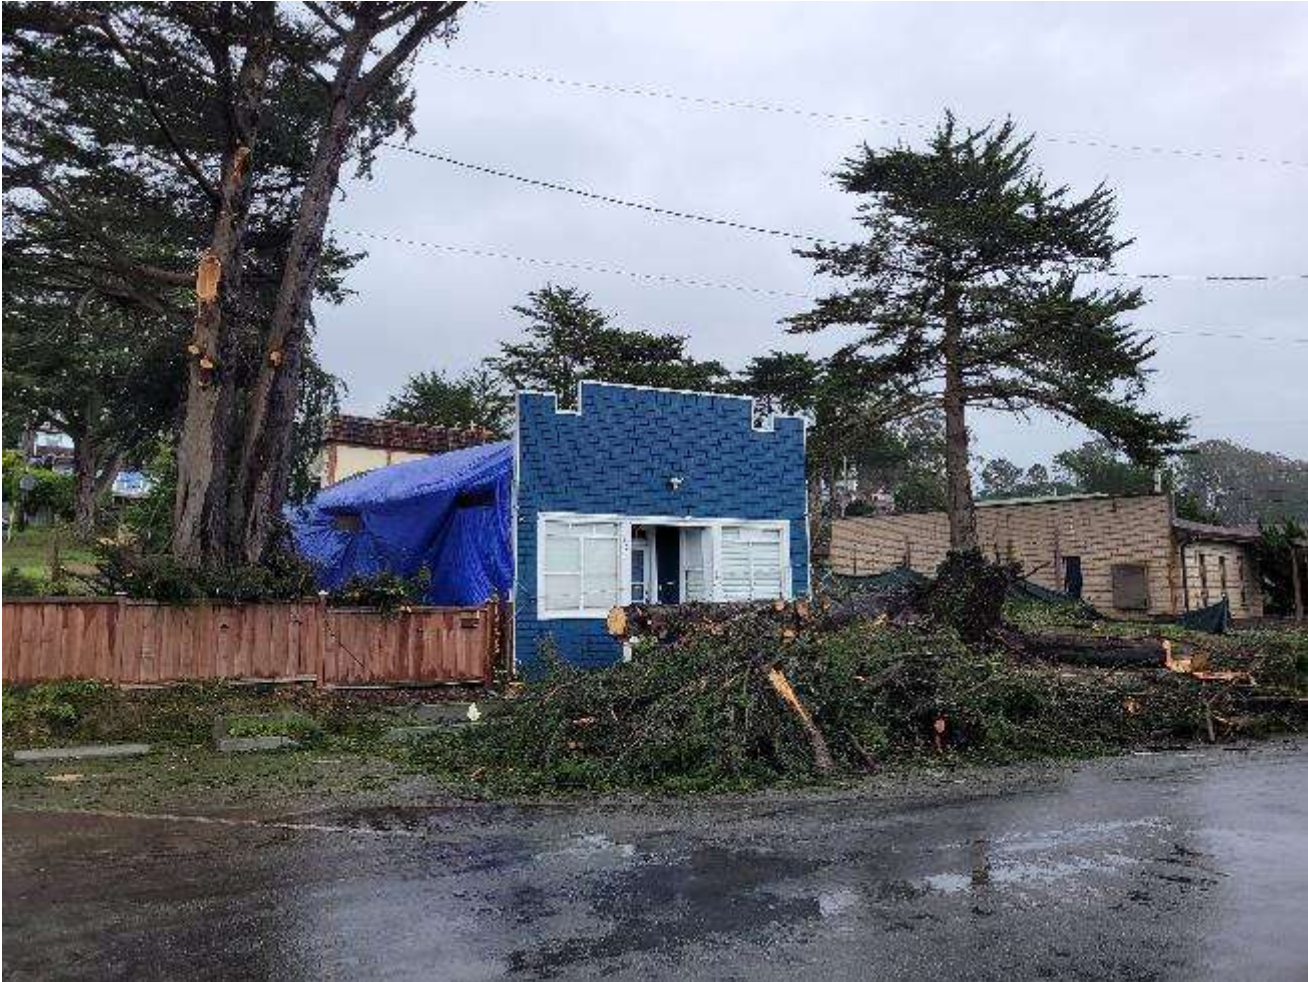
B. The picture below shows the home destroyed by a falling tree after the New Years' Eve storm of 2023:

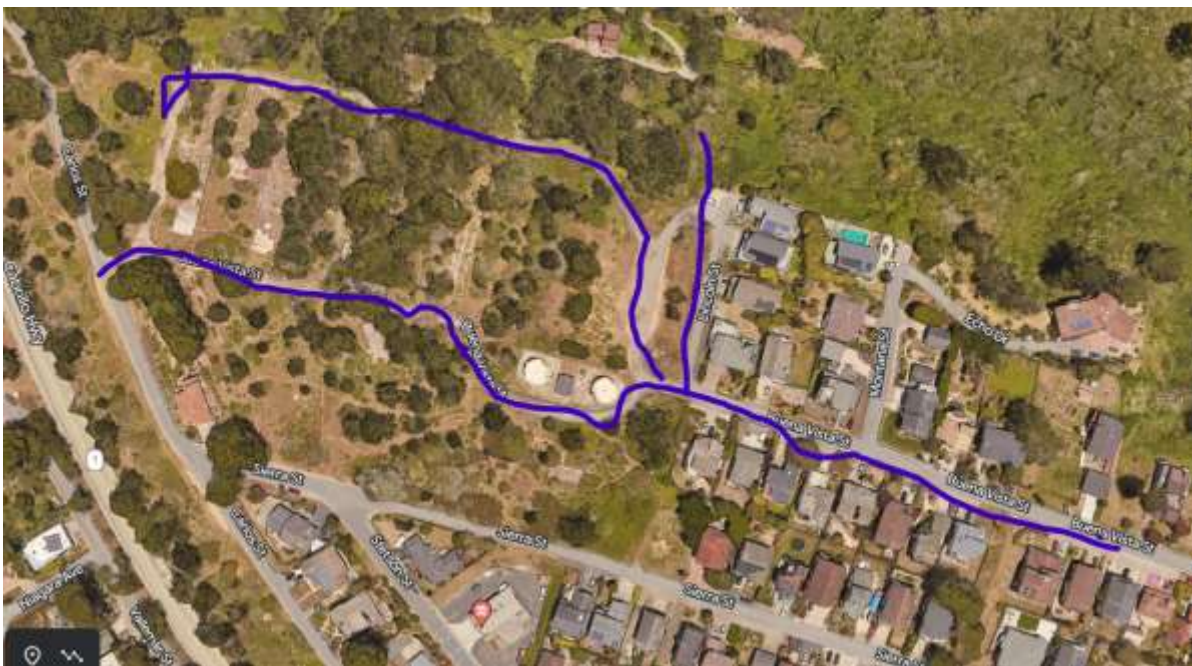
Currently, according to local residents who provide the following information, the Project site serves as an “ad hoc stormwater retention basin”, which reaches 2 feet of depth near the MWSD water tanks during storms. A longtime resident’s description of the drainage is as follows:

“Area from the crest of Buena Vista [technically, this is 18<sup>th</sup> St. on County parcel maps] to the Carlos exit.

Blue lines illustrate water run off directions. Downhill slope is right to left [East to West] through Cypress Point Project. Primary final drainage exit is at the Carlos exit. There is severe road erosion all along the road that runs in front of the water towers due to volume of water run-off every winter. The upper hill run-off joins the Carlos and upper streets draining on to Highway 1. Result is often seen as water rushing out of the Carlos St exit and soil/rock deposits on the road. Additional drainage from Buena Vista goes down Lincoln St toward the creek or open area. Result is a large water pool in the open area that flows down the side road; or into the creek. Additional pooling occurs right of the two water towers. All runoff drains into the ocean.

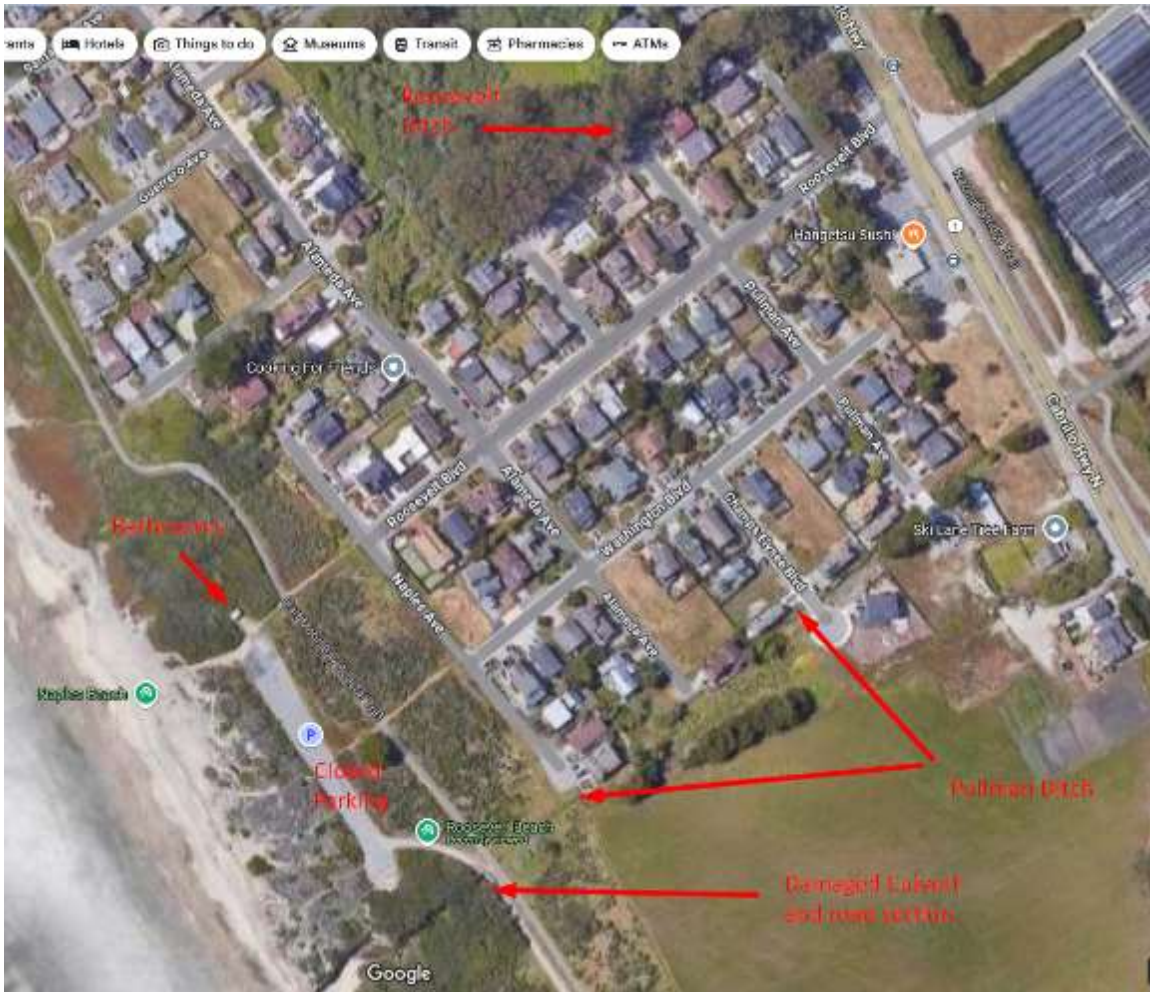
This area of Miramar is part of HMB, and is not MCC jurisdiction, but residents contacted us because of two types of flooding in two ditches, and because of the loss of a valued Coastside recreation facility at Roosevelt beach. The storm drainage has been so compromised that it damaged the culvert at the west end of the beach parking lot, and the adjacent road. It appears that rather than repair the culvert and roadway, the decision made was to close the road, blocking off access to a valuable beach parking lot and to close the restrooms at the end of the parking lot (presumably due to lack of access for septic services).

The two ditches involved are the Roosevelt ditch to the north, and the Pullman ditch shown on the map. In both ditches, residents report winter flooding which has overtaken the first floor of their homes (e.g. Rossi residence at 2804 Champs Elysee Blvd), or reached their foundations.

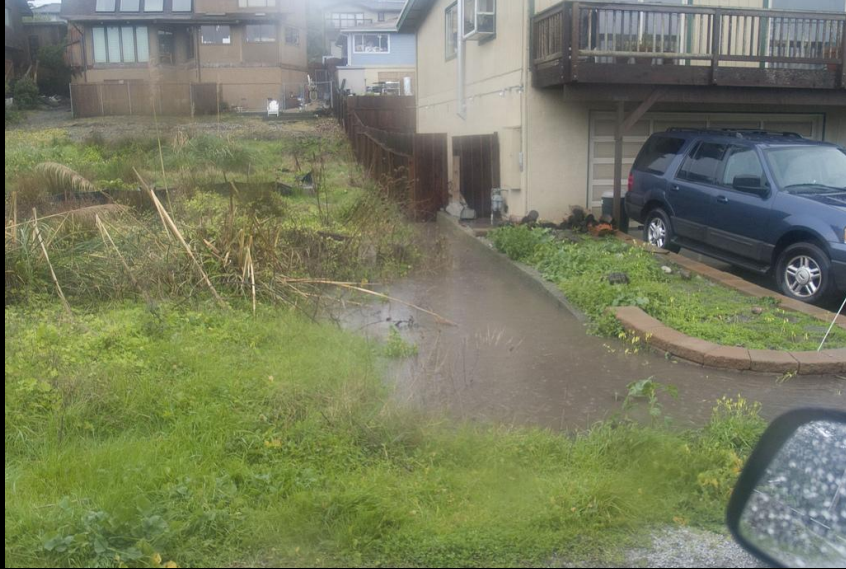
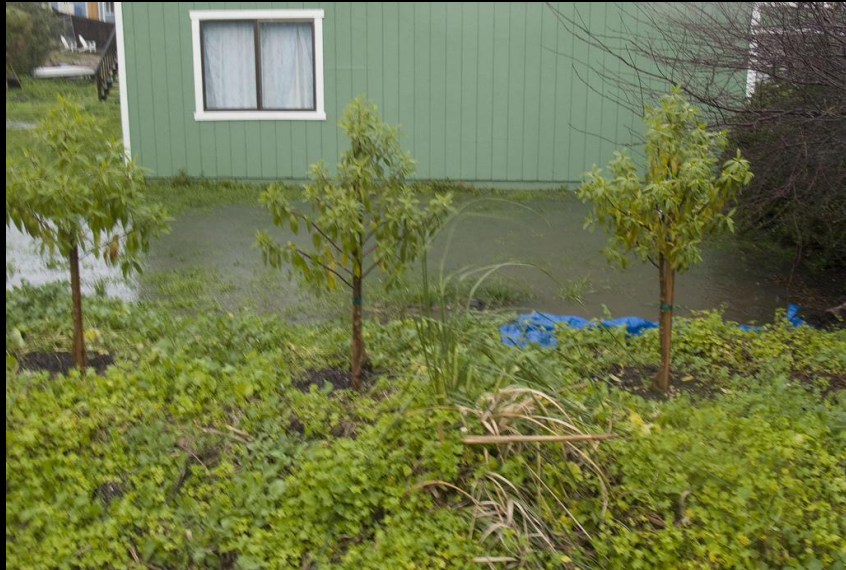
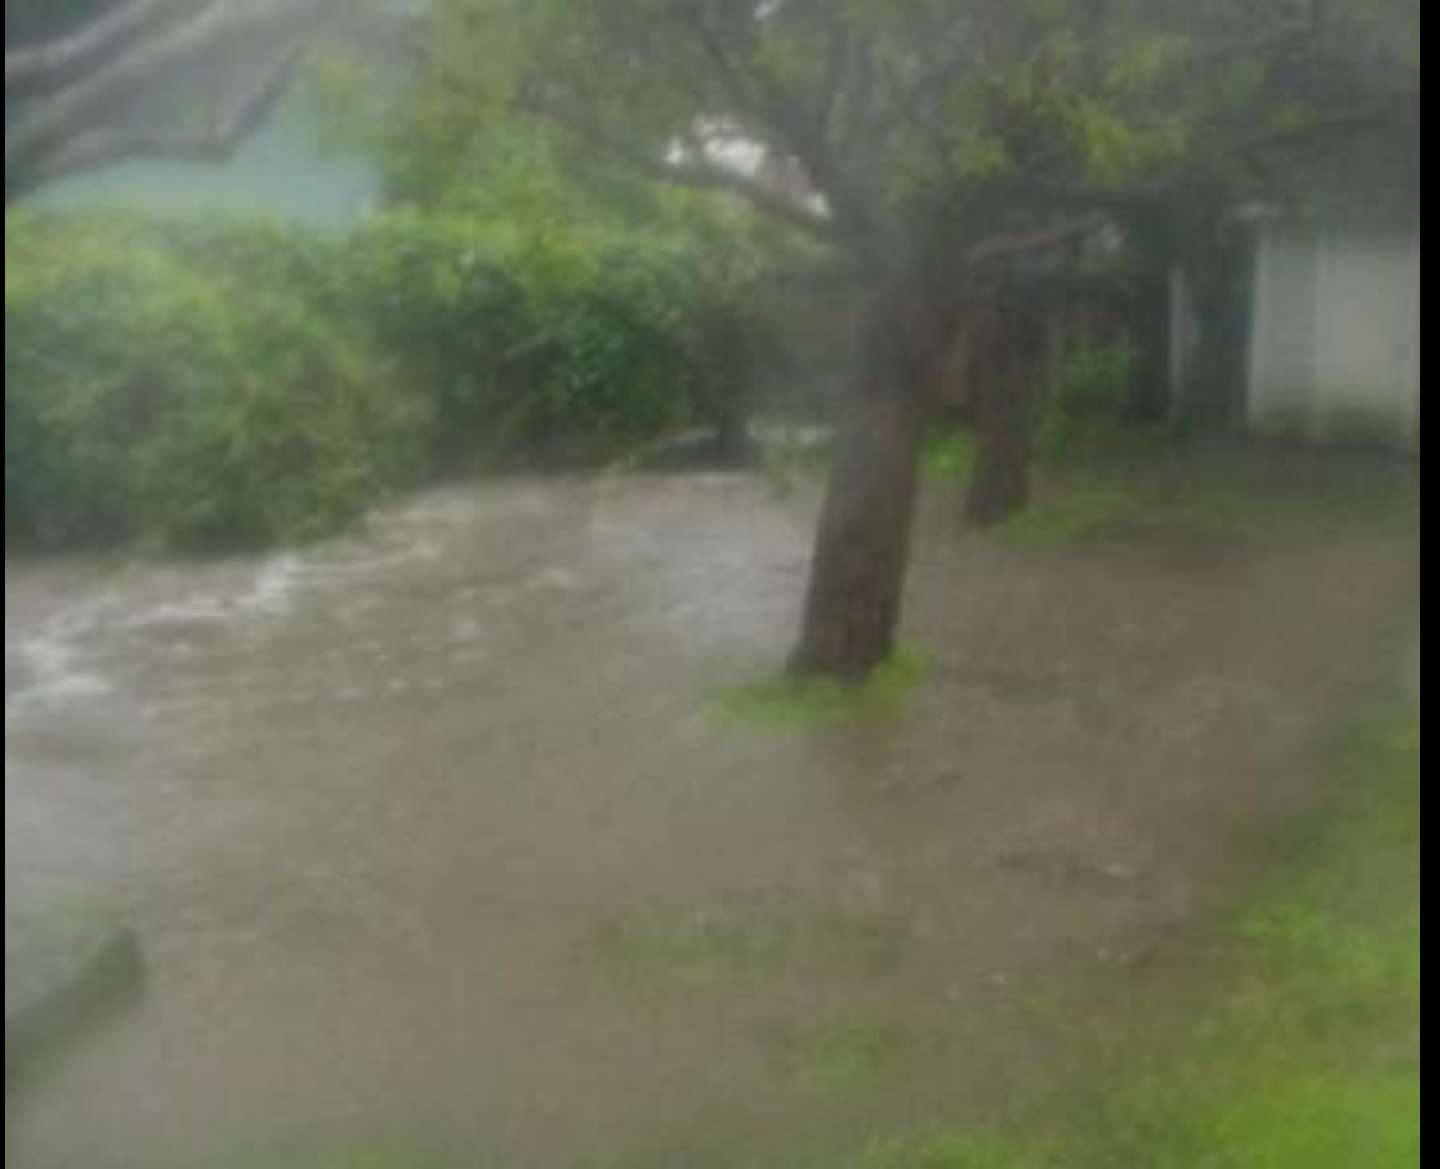
## 2nd Street Properties Flooded

Water from multiple locations is directed through homeowner's front and backyards.

Flooding in 2005, 2008, 2014, 2015 and 2022.

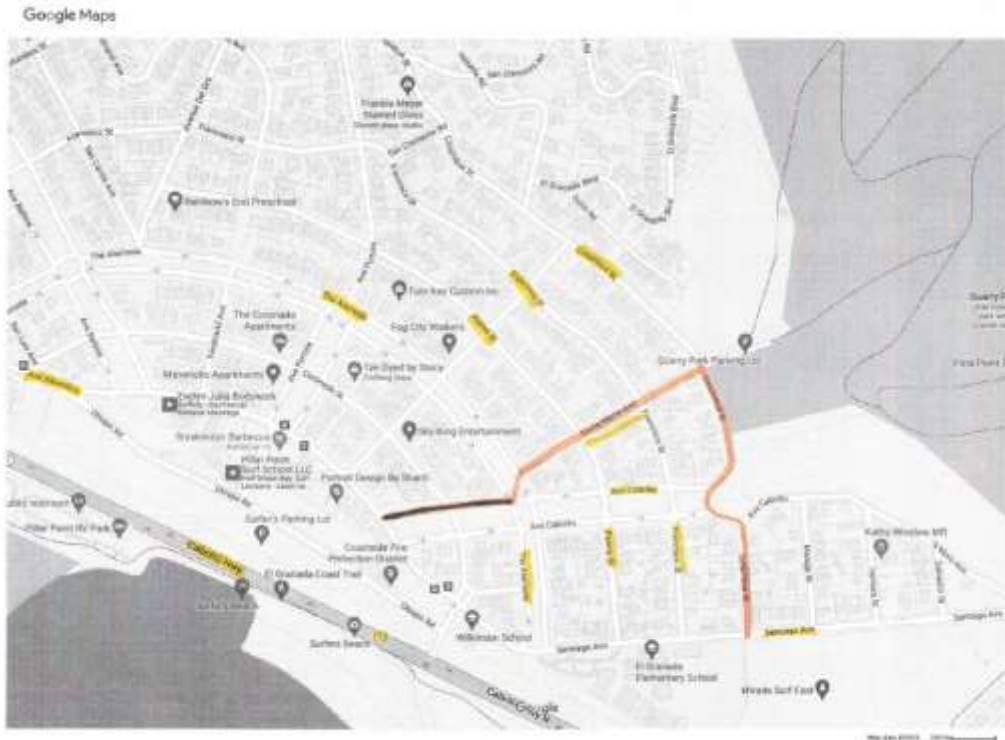
The two flows exit the Park at the intersection of Santa Maria Ave. & Columbus St near the Park's entrance (see Photos 03, 07, & 18 in Exhibit 2). The larger and more impactful flow floods down Santa Maria whereas the lesser flow, until recently, also primarily flooded down Santa Maria with a much lesser impact to Columbus. Recently though, because of the quantity of flooding stormwater, such as after the January 2023 storm (see Photos 18 to 25), the SMC Parks Department diverted the lesser flow down Columbus (see Photos 01 to 05). This helped reduce the flooding down Santa Maria and its impact to homes on that street and, for which, the residents were greatly thankful<sup>12</sup>. Nonetheless, this newly increased diverted flow adversely effected the health & safety of residents on Columbus with Park flows flooding down 3 blocks (approx. 1,200 linear ft.) to a pseudo storm drain at Santiago Ave. then under that road to openly run into a meadow on the road's western side (see Photos 05 & 06).

Photo 01 - Diverting lesser stormwater flow from Quarry Park at Park entrance (intersection of Santa Maria & Columbus)

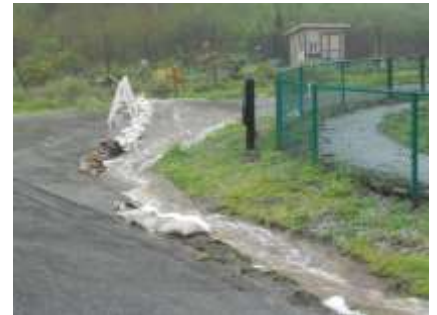
Photo 02 - Diverted lesser stormwater flow from Quarry Park at Park entrance (intersection of Santa Maria & Columbus)

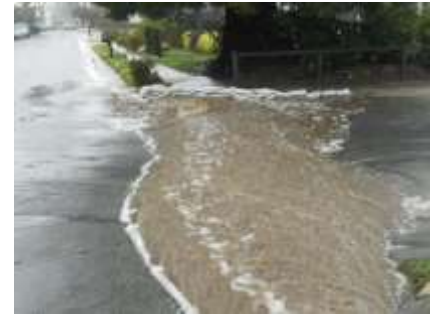
The Park's larger stormwater flow onto and down Santa Maria starts at the Park's entrance then floods over cross streets beginning with Columbus, then to Francisco, then to Palma into a pseudo storm drain at the end of Santa Maria at intersection with The Alameda (see Photos 07 to 12). The stormwater runoff then floods under the east side of The Alameda to an open-air ditch in its median to a new catch basin at Ave. Cabrillo (see Photos 13 & 14). At the Ave. Cabrillo catch basin, stormwater enters an underground storm system flowing down Ave. Cabrillo to a storm drain as part of the underground storm system at Ave. Alhambra (see Photos 15 to 17). This process catches all of the runoff down Santa Maria even when the lesser flow from the Park is not diverted by the Parks Dept. - but the flooding is much more intense getting to the drain in that case.

Photo 08 - Larger Park stormwater flow flooding down Santa Maria at intersection of Santa Maria & Columbus

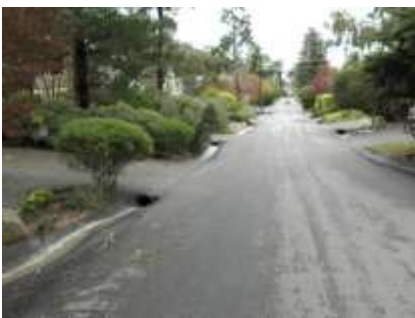
Photo 29 - Deep open-air ditches down Ave. Portola towards Francisco

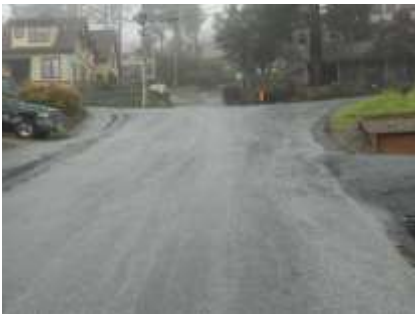
Photo 40 - Runoff from intersection of Ave. Del Oro & Columbus

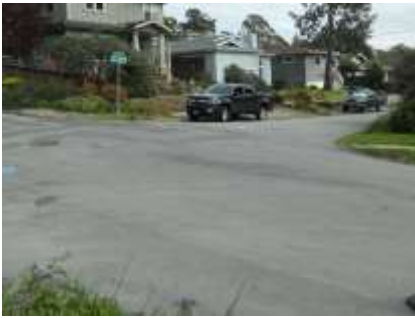
Photo 45 - Intersection of San Carlos & Columbus

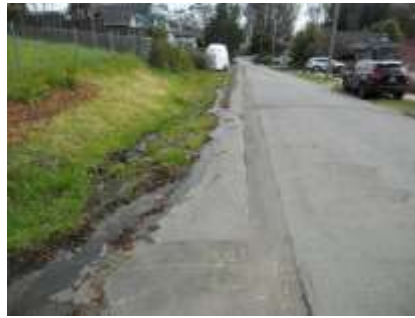
Photo 46 - Runoff down San Carlos to Francisco from Columbus

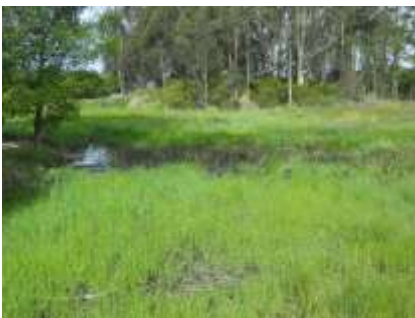
Sonora (see Photos 64 to 67). The area with the pool behind the homes was discovered to be wetlands (see Photos 67 to 69).

Photo 69 - Wetlands behind homes towards storm pooling site (4/15/2023)

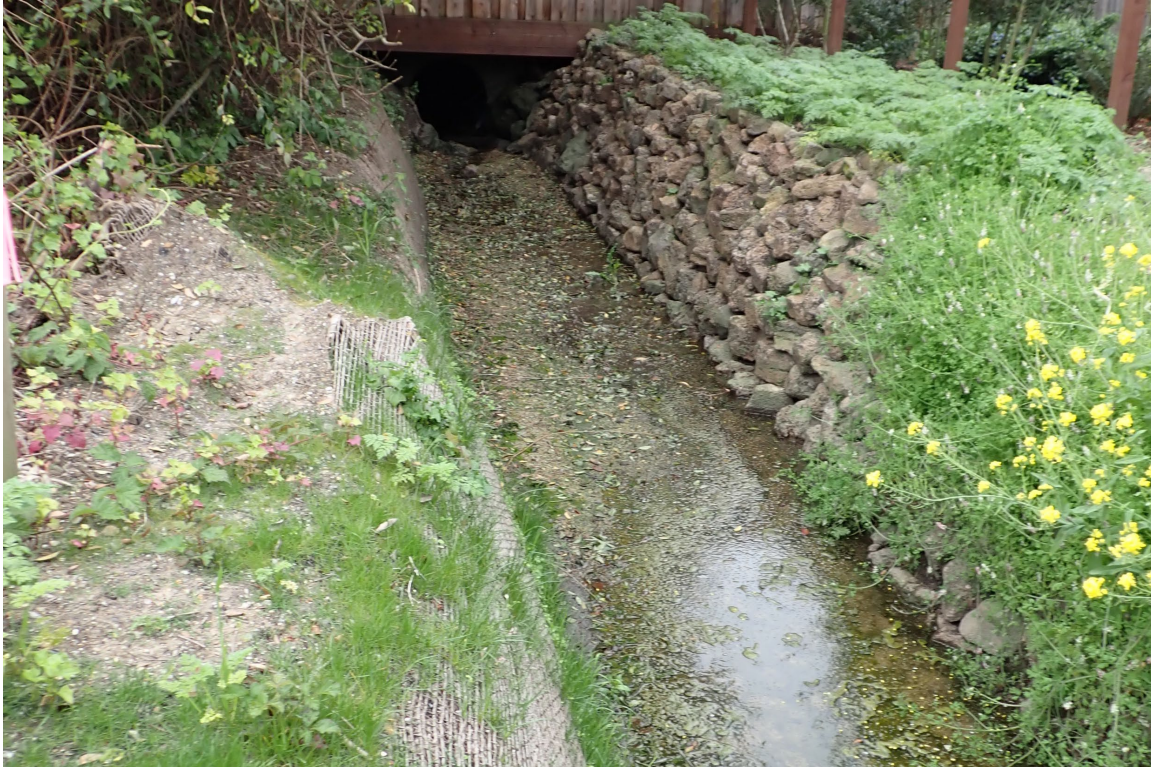
Bridges crossed the Ditch northeast of the Highway 1 inlet, at Pullman Avenue, and at Champs Elysee Avenue (Figures 19 through 21). The majority of the open channel portions of the Ditch were vegetated earthen channels with irregular cross section (Figures 22 through 24), with a concrete barrier bordering the northeast bank at the end of Alameda Avenue (Figure 25), a concrete bank wall upstream of 2805 Naples Avenue (Figure 26), an irregular poured concrete outlet apron downstream of 2805 Naples Avenue (Figure 27), and a timber retaining wall on the northeast bank at the 2805 Naples Avenue outlet (Figures 13 and 28). Downstream of the culvert crossing under 2805 Naples Avenue, soil loss was visible behind the timber retaining wall (Figure 29) and under the concrete apron (Figure 27). The section of the Ditch fronting the Rossi Residence had more uniform trapezoidal cross section than other open channel reaches of the Ditch, with rock armoring on one bank and jute netting on the other (Figure 30).

**Figure 29** Soil loss behind upstream end of timber retaining wall at 2805 Naples Ave

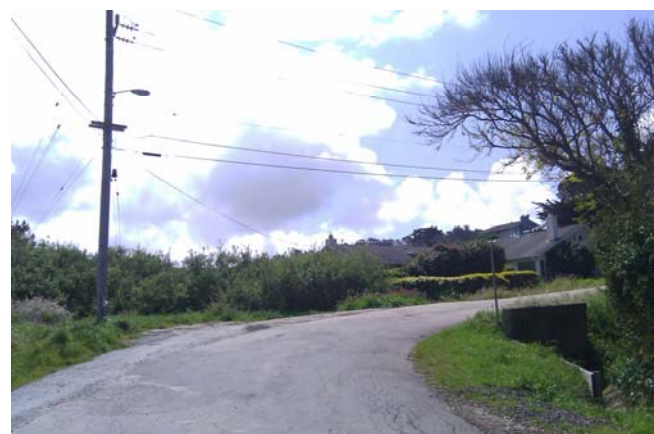
The western end of the study area at Kanoff Street is the lowest point in elevation of the entire study area (see Photo 5). Just west of the residence at Kanoff Street is another wetland area, dominated by native willows, nonnative blackberries and German ivy (see Photo 5). This wetland area connects to the blue line creek shown on the USGS Montara Mountain quadrangle, and also connects to the newly created wetland mitigation pond created by Caltrans. It is also hydrologically connected to the large willow thicket in the natural area just east of the corner where Kanoff Street turns to Farallone Avenue (see Photo 6).

**Photo 6.** Looking at the northeast corner where Kanoff Street turns to Farallone Avenue to photo right. Note the large willow thicket in the photo background.

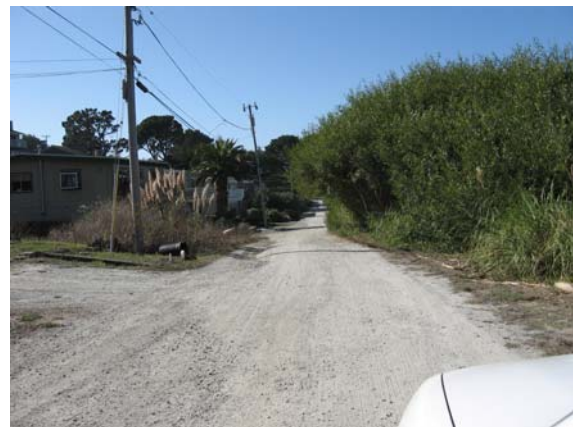
From Catchment Point 1 (CP1) to CP2, a 3 feet deep earthen ditch conveys runoff into a “flat area with no distinguishable toe or bank” adjacent to Second Street. This area is heavily overgrown with vegetation as shown in the photograph (to the right of the road), so a Manning’s channel roughness coefficient (n) of .08 is assumed; representing conditions of brush and trees in a floodplain. Higher ground to the north of the swale forces the natural release of floodwaters onto Second Street and adjacent low lying properties to the south. The driveway elevation at 360 Second Street is nearly one foot lower than the swale containment elevation.

CP1 to CP2: Existing drainage facilities could be enlarged as required to pass the peak flows for a given return period. By clearing a swath of vegetation north of Second Street and constructing a clean channel with appropriate erosion control, the 100-year peak discharge (100 cfs) could be passed without flooding adjacent properties. Assuming the improved channel can be maintained with some weeds and light brush on the banks (Manning's "n" of 0.045), a five- to ten-foot meandering channel bottom, and grade control structures limiting the longitudinal slope to about one percent (keeping flow velocities to less than five feet per second), the depth of channel required to carry the 100-year flow is about 2.5 feet. This option would require periodic maintenance to prevent the establishment of woody vegetation within the channel or banks.

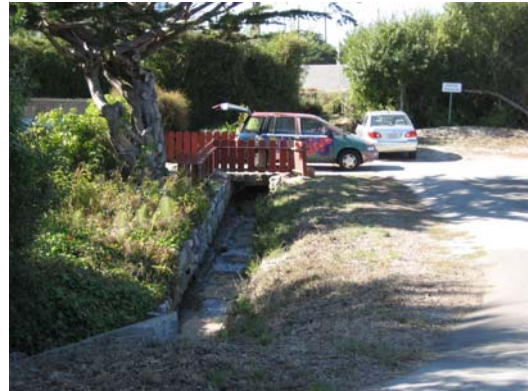
Drainage from CP2 to CP3 is routed downstream in a 4 feet wide concrete box channel. The driveway crossing tends to choke flow since the headroom is only about 1.4 feet and inlet control governs. Excess flow would tend to flow to lower ground to the south and west. This channel continues into dense brush to the north and eventually discharges into the Caltrans wetland mitigation site. The safe release elevation for this storage area (39 feet at Highway 1) is more than ten feet lower than driveway elevations along First Street.

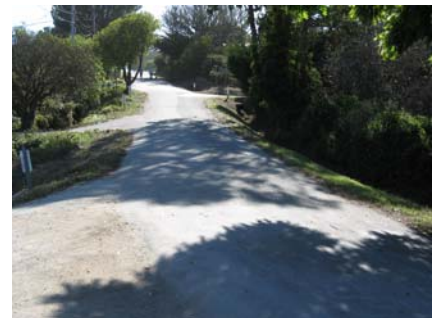
Farallone to CP2: As evidenced by Table 5, the ditches running parallel to Farallone Avenue from Second Street to Kanoff Street have sufficient capacity; it is the undersized CMP crossings that choke the flow and cause storm runoff to spill onto private property. Kanoff Street is steep in this location (with a slope of 12 percent), so culvert hydraulics are inlet control; that is, the culvert capacity is controlled by the pipe diameter and inlet condition (headwall, projecting pipe, etc.).

Existing CMP crossings could be upsized, with a commensurate increase in depth to accommodate the larger pipe. Assuming a minimum two feet of cover (the approximate amount of cover at most existing crossings), the size of necessary replacement culverts (without building headwalls) are summarized in Table 7.

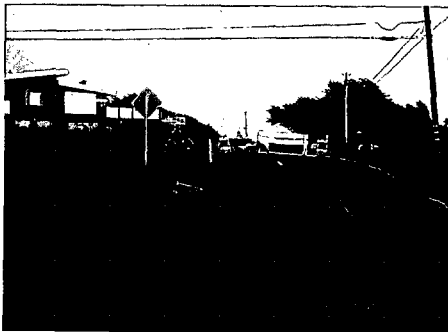
The depression shown here is the graben along the top of the rotating slide mass. The picture was taken facing southward, and the white barrier is at the intersection of Ocean and San Lucas.

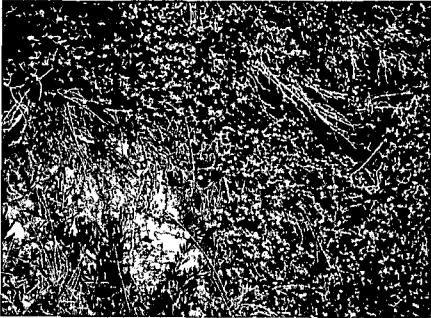
There is a fresh west-facing scarp that runs through this over-steepened portion of the road, and through the vacant lot, just below the light blue house. This scarp shows fresh soil, but its precise extent is impossible to determine due to dense vegetation.

There is water flowing through this vacant lot, close to this scarp. The source of this flow was not determined.

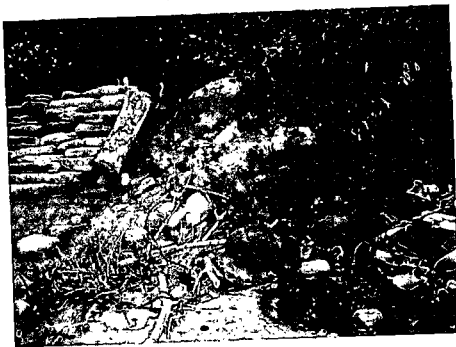
This is another photo showing the swale below the road, but looking slightly more northward than the previous one. The cement "steps" are in the middle at the base of the slope here, for reference. The benched form of the slope is evident, as is the lack of recent movement at the beach level.

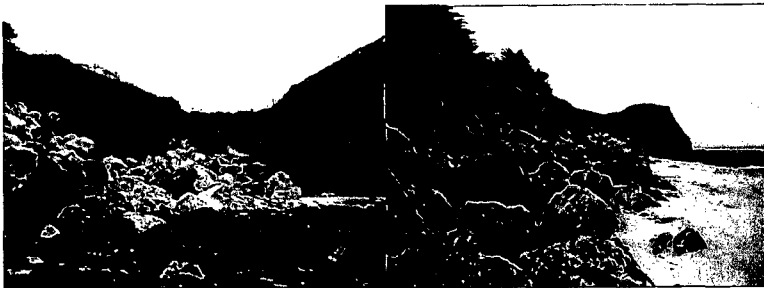
The left photo shows the small cove below the Distillery, which can be seen on the top of the bluff to the left. The picture on the right shows riprap on the beach near one of the houses that sits almost right on the beach. The exposed cliff on the right of the Distillery picture is visible in the distance on the right photo.

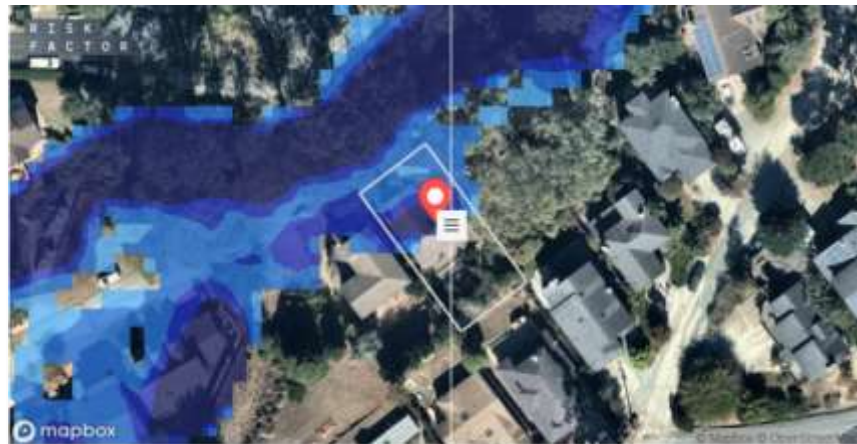
Upper Vallejo Street (from 606 Vallejo Street)

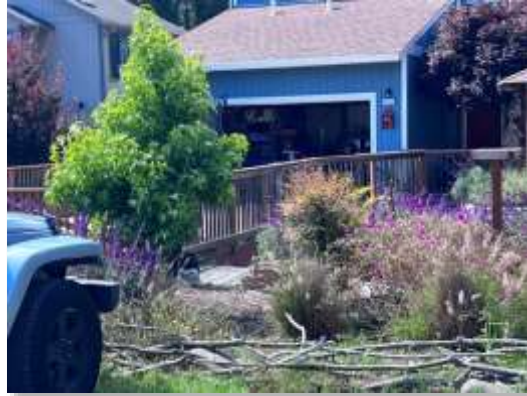
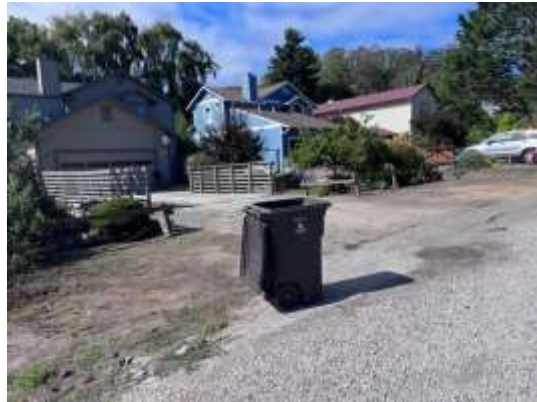
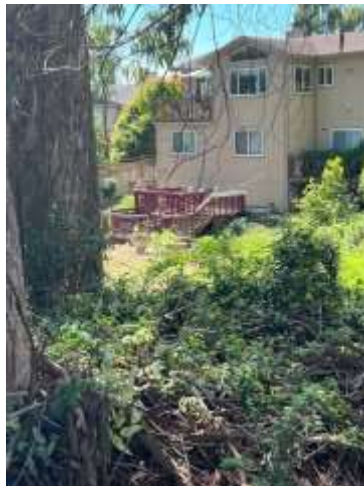
Houses Built Along the Edge with Driveways over the Creek

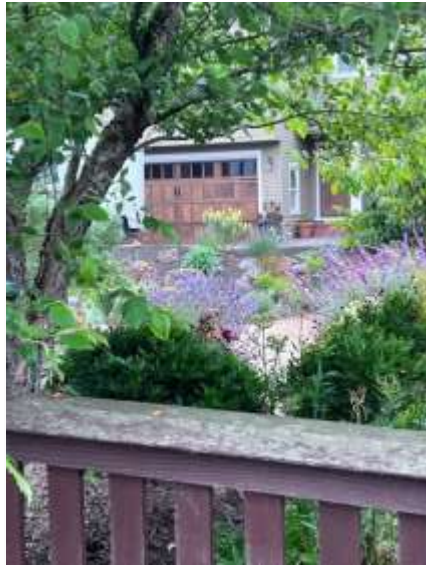
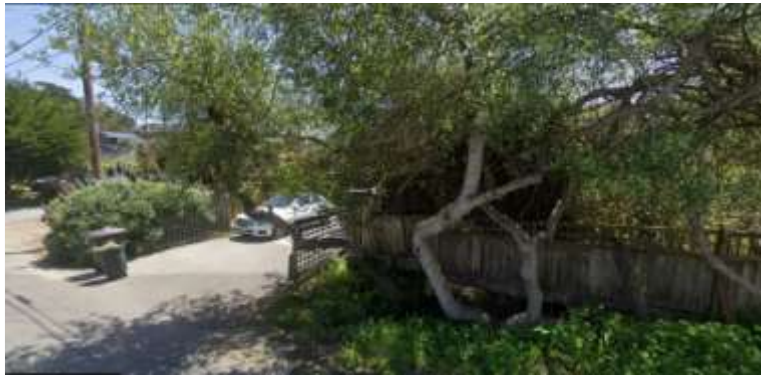
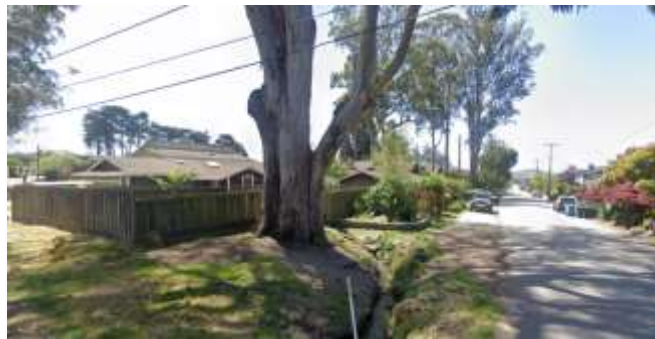
## Homes with Deer Creek Running Through Yards

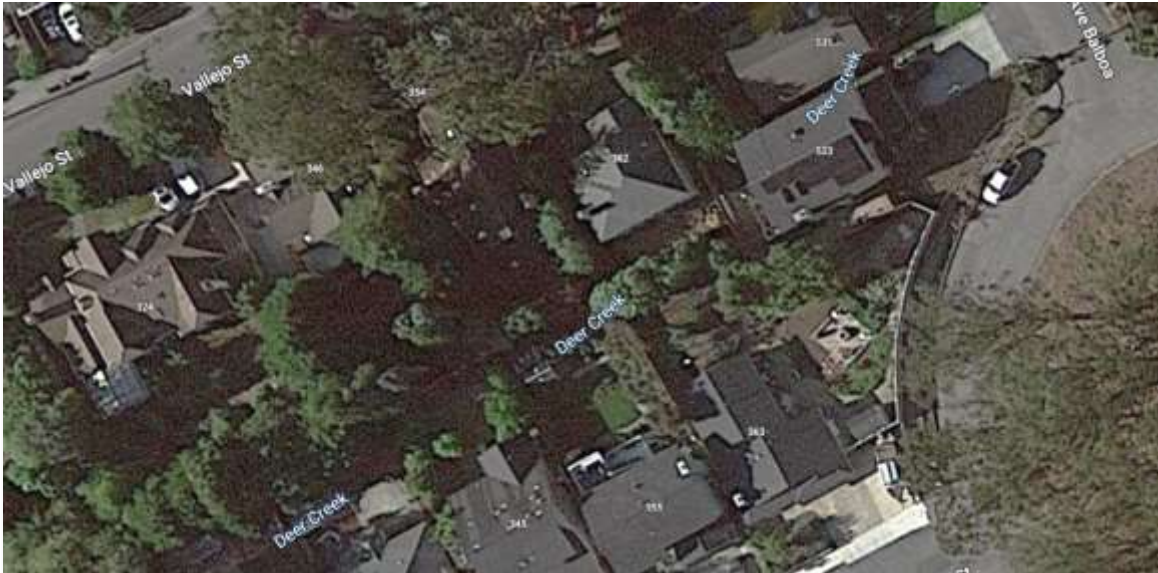
## Intermixed with Housing In Lowest Elevations El Granada

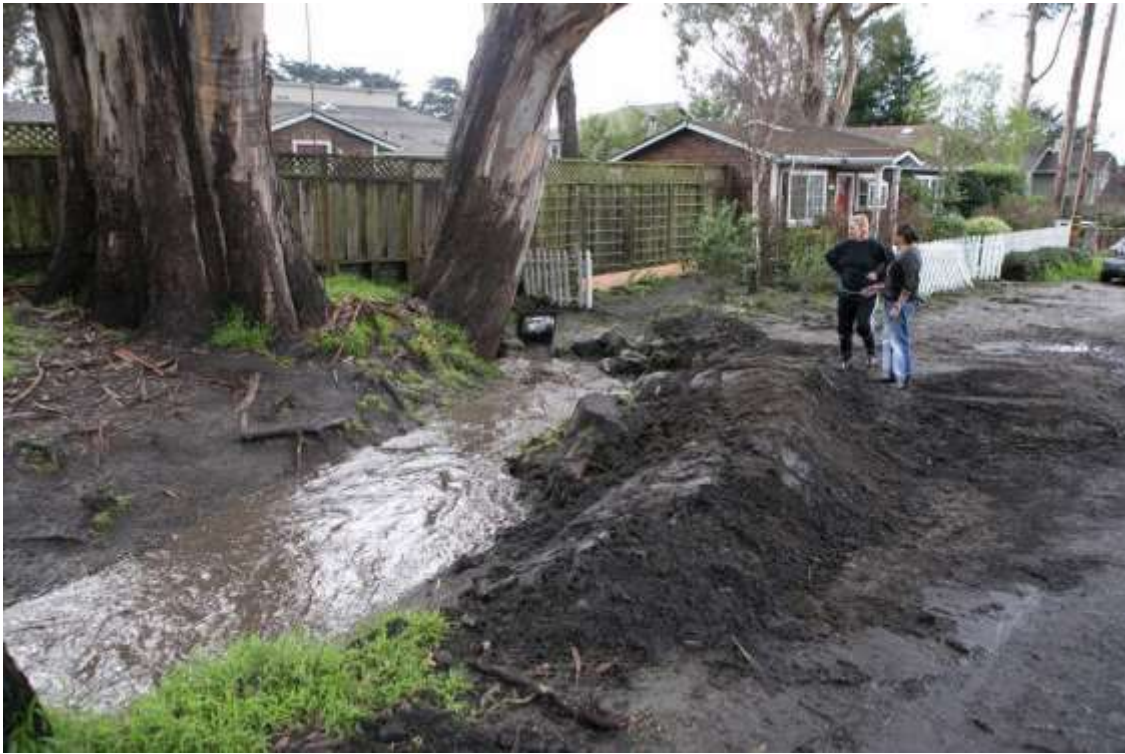
**Photo from Half Moon Bay Review Feb. 23, 2017 of Deer Creek flooding onto Vallejo Street**

Neighbors believed someone had made changes to the creek upstream that exacerbated the flooding problem. Prior to the makeshift berm, water was diverted from one home, only to flow into another neighbor's home.
